Reference: NHTSA Identification Number 04V-099

Dealer Service Instructions for:

Safety Recall No. D12 Roof Foam Inserts

- 2004 (VA) Dodge Sprinter 2500/3500**
(VA) Freightliner Sprinter 2500/3500

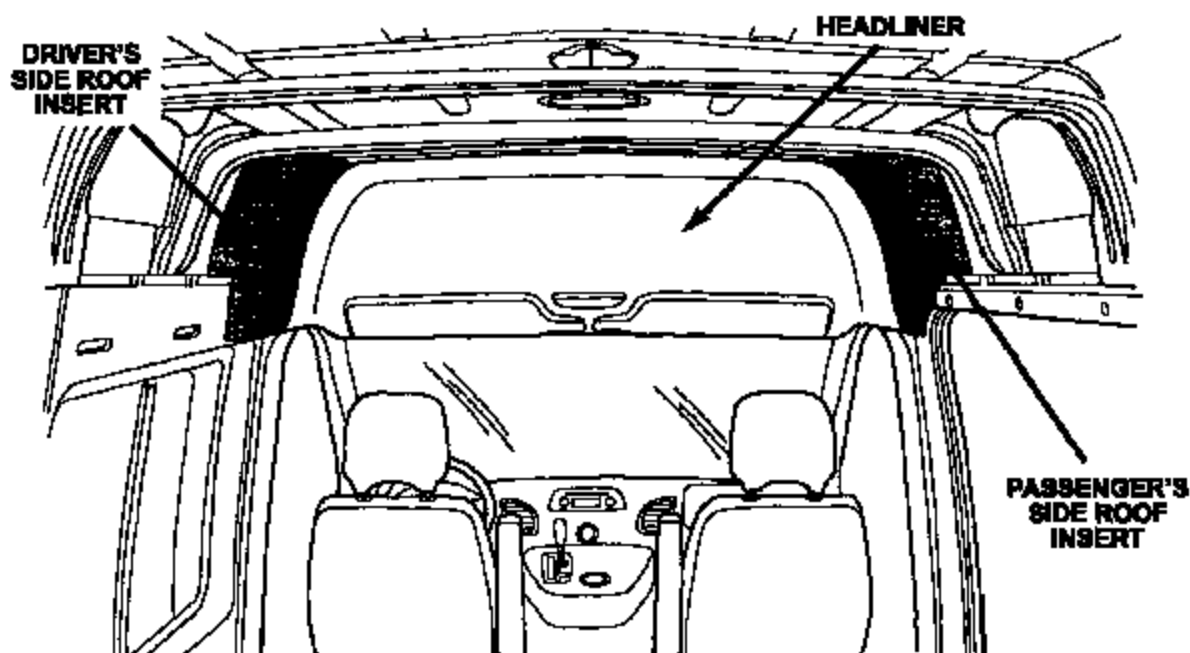
Figure 1 – High Roof Model Shown

1. Open the rear doors and inspect for black roof foam inserts located just behind the front seats near the roof (Figure 1).
 - If the roof foam inserts are present on both sides as shown in Figure 1, no further action is required. Return the vehicle to the customer.
 - If no roof foam inserts are present, roof foam inserts must be installed. Continue with Step 2 of this procedure.
