# Recall Bulletin

File In Section: Product Recalls  
Bulletin No.: 04010  
Date: March 2004

**SUBJECT: BRAKE PEDAL ASSEMBLY**

**MODELS: 2004 CHEVROLET KODIAK  
2004 GMC TOPKICK**

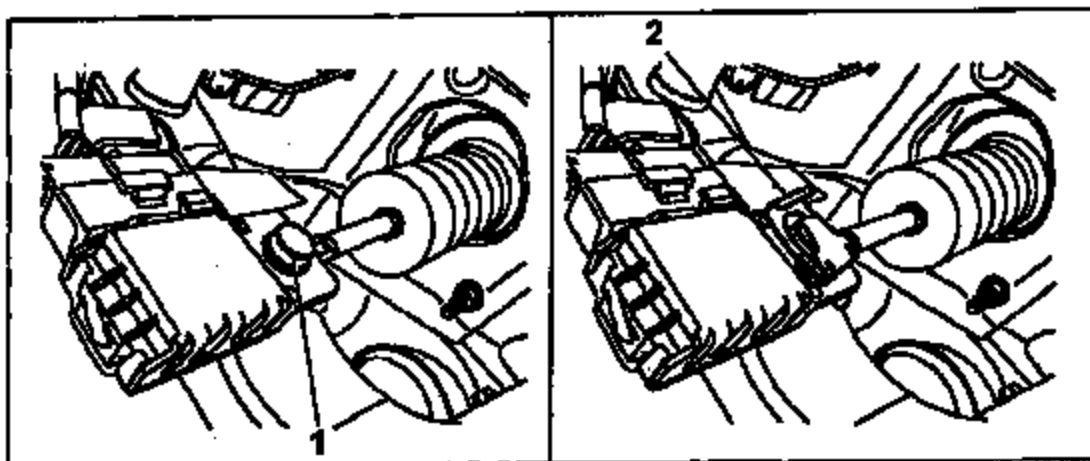
1467868

General Motors has decided that a defect, which relates to motor vehicle safety, exists in certain 2004 model year Chevrolet Kodiak and GMC TopKick vehicles. Some of these vehicles are missing a retainer that holds the brake booster push rod and the brake pedal together. If the retainer is missing, the push rod and pedal could separate resulting in a loss of foundation brakes. If this condition occurs where stopping distance is limited, a crash could occur.

1. Open the driver's door and from underneath the instrument panel check to see if there is a retaining clip (2) on the end of the pivot shaft (1) where the brake switch and pushrod attach to the brake pedal arm.
  - If the retaining clip (2) is MISSING, then a new retaining clip needs to be installed. Proceed to the next step.
  - If there IS a retaining clip (2) then no further action is required.
2. Verify that the brake switch and pushrod are completely on the pivot shaft.
3. Install a new retaining clip on the end of the pivot shaft. A click or snap-like sound should be heard when the clip is fully engaged.
4. Depress the brake pedal and check for proper brake light operation.
