Subject: 04007 Product Safety Recall
Tailgate Support Cable

File In Section: Product Recalls
Bulletin No.: 04007
Date: September 2004

SUBJECT: TAILGATE SUPPORT CABLE

**MODELS: 2002-2004 CADILLAC ESCALADE EXT
2000 CHEVROLET CK
2000-2004 CHEVROLET SILVERADO
2002-2004 CHEVROLET AVALANCHE
2000-2004 GMC SIERRA**

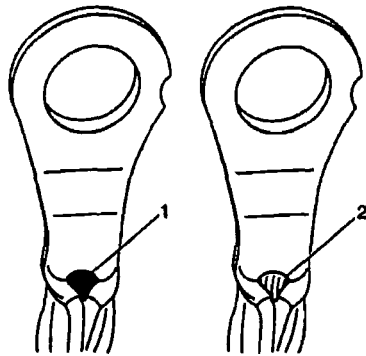
1545570

In the above illustration, the clear sealant (1) is shown as black in color. This was done for illustration purposes only. If sealant is present on the support cables it will be clear or hazy (cloudy) in appearance.

3. Inspect the end (eyelet) of the support cable that attaches to the tailgate for sealant covering the end of the cable strands.
 - o If there IS a clear type sealant (1) over the end of the cable strands, the support cable needs to be replaced. Reconnect the support cable to the pickup box and perform this same inspection on the left support cable. After inspecting both cables, proceed to the section titled, "Hinge Inspection."
 - o If there IS NOT a clear type sealant (2) over the end of the cable strands, that support cable does NOT need to be replaced. Reconnect the support cable to the pickup box and perform this same inspection on the left support cable. After inspecting both cables, proceed to the section titled, "Hinge Inspection."

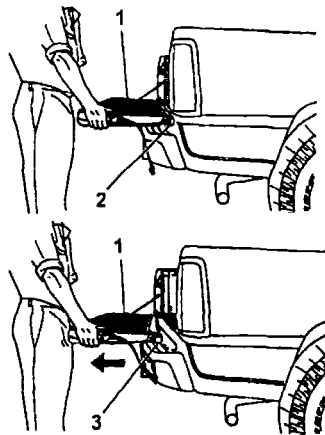
1538695

2. With the tailgate (1) completely open as shown in the upper part of the illustration, pull the RIGHT SIDE of the tailgate rearward as shown in the lower illustration. Do not pull on the left side of the tailgate.
 - o If the tailgate hinge (2) will NOT disengage from the pickup box on the right side, no repair is needed to the hinge. Proceed to the section titled, "Support Cable Replacement," and replace any support cables that HAD sealant in the earlier inspection. If neither of the support cables requires replacement, no further action is required.
 - o If the tailgate hinge (3) will disengage from the pickup box on the right side, the hinge needs to be replaced. Proceed to the section titled, "Hinge Replacement" before proceeding with the replacement (if necessary) of the support cables.

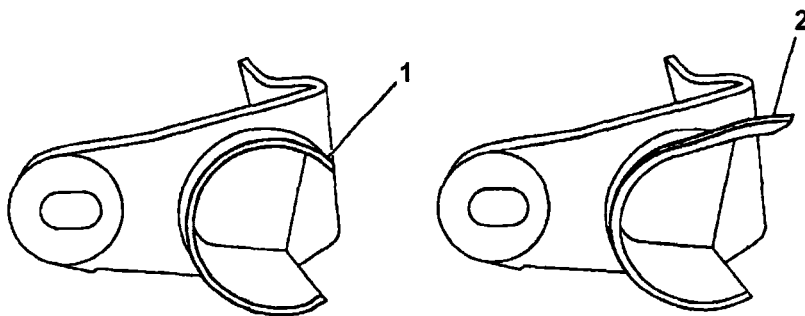
1538698

1. With the right side of the tailgate disengaged from the pickup box, inspect the hinge on the right side of the tailgate for damage. The illustration above shows an undamaged hinge (1), and a damaged or bent hinge (2). Proceed to the next step for replacement of a damaged hinge.
2. Release (unhook) the left side tailgate support cable from the pickup box.
3. Remove the tailgate from the vehicle

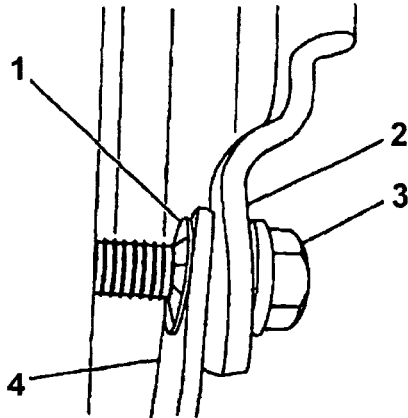
1466543

If the support cable (2) has NOT been replaced previously, there will be a toothed nut (1) located between the latch (4) and the tailgate that will prevent the bolt (3) from being removed in the next step. The nut is an assembly aid used in the assembly plant. The nut does NOT need to be reinstalled or replaced when installing a new support cable in this recall.
