GM SERVICE AND PARTS OPERATIONS
DCS1282
URGENT DISTRIBUTE IMMEDIATELY

Subject: 04007A - Product Safety Recall
Tailgate Support Cable
Parts Availability Update

Models: 2002-2004 Cadillac Escalade EXT
2000 Chevrolet C/K
2000-2004 Chevrolet Silverado
2002-2004 Chevrolet Avalanche
2000-2004 GMC Sierra

Bulletin No.: 04007A

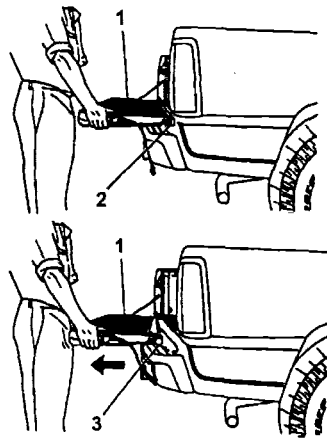
1538695

1. Release (unhook) the RIGHT side tailgate support cable from the pickup box.
2. With the tailgate (1) completely open as shown in the upper part of the illustration, pull the RIGHT SIDE of the tailgate rearward as shown in the lower illustration. Do not pull on the left side of the tailgate.
 - o If the tailgate hinge (2) will NOT disengage from the pickup box on the right side, no repair is needed to the hinge. Proceed to the section titled, "Support Cable Replacement", and replace both support cables.
 - o If the tailgate hinge (3) WILL disengage from the pickup box on the right side, proceed to the next step.

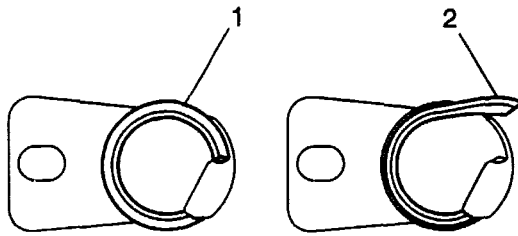
1553673

3. With the right side of the tailgate disengaged from the pickup box, inspect the hinge on the right side of the tailgate for damage. The illustration above shows an undamaged hinge (1) and a damaged or bent hinge (2).
 - o If the hinge is undamaged (1), no repair is needed to the hinge. Proceed to the section titled, "Support Cable Replacement", and replace both support cables.
 - o If the hinge IS damaged or bent (2), the hinge needs to be replaced. Proceed to the section titled, "Hinge Replacement", before proceeding with the replacement of the support cables.

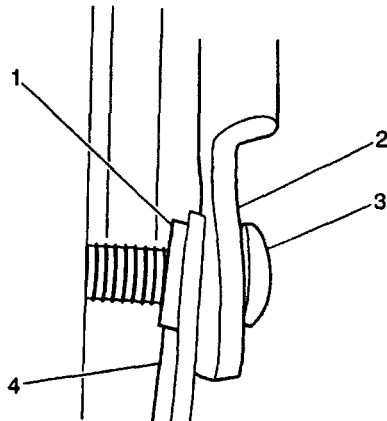
1551939

If the support cable (2) has NOT been replaced previously, there will be a toothed nut or plastic nut (1) located between the latch (4) and the tailgate that MAY prevent the bolt (3) from being removed in the next step. The nut is an assembly aid used in the assembly plant. Do not reinstall or replace the toothed or plastic nut when installing the new support cable.

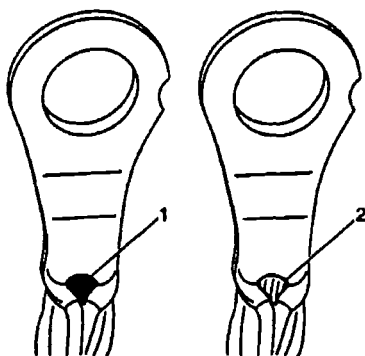
1545570

In the above illustration, the clear sealant (1) is shown as black in color. This was done for illustration purposes only. If sealant is present on the support cables it will be clear or hazy (cloudy) in appearance.

3. Inspect the end (eyelet) of the support cable that attaches to the tailgate for sealant covering the end of the cable strands.
 - o If there IS a clear type sealant (1) over the end of the cable strands, the support cable needs to be replaced. Reconnect the support cable to the pickup box and perform this same inspection on the left support cable. After inspecting both cables, proceed to the section titled, "Hinge Inspection."
 - o If there IS NOT a clear type sealant (2) over the end of the cable strands, that support cable does NOT need to be replaced. Reconnect the support cable to the pickup box and perform this same inspection on the left support cable. After inspecting both cables, proceed to the section titled, "Hinge Inspection."

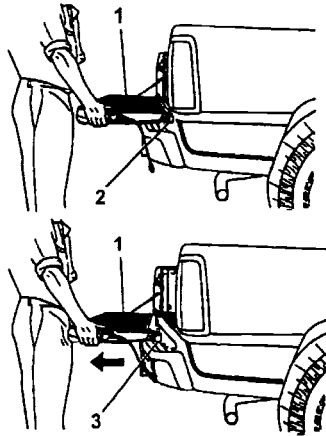
1538695

1. Release (unhook) the RIGHT side tailgate support cable from the pickup box again.
2. With the tailgate (1) completely open as shown in the upper part of the illustration, pull the RIGHT SIDE of the tailgate rearward as shown in the lower illustration. Do not pull on the left side of the tailgate.
 - o If the tailgate hinge (2) will NOT disengage from the pickup box on the right side, no repair is needed to the hinge. Proceed to the section titled, "Support Cable Replacement," and replace any support cables that HAD sealant in the earlier inspection. If neither of the support cables require replacement, no further action is required.
 - o If the tailgate hinge (3) will disengage from the pickup box on the right side, proceed to the next step.

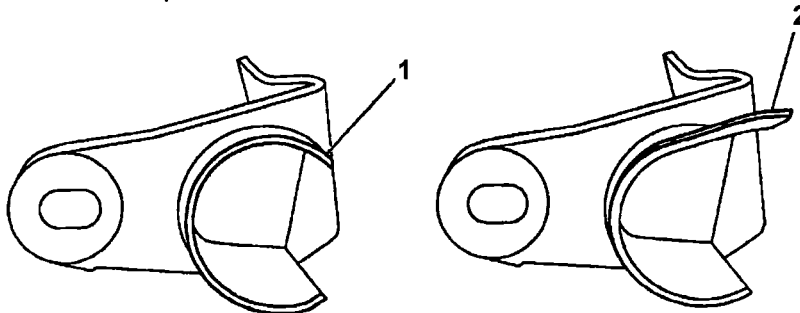
1538698

2. With the right side of the tailgate disengaged from the pickup box, inspect the hinge on the right side of the tailgate for damage. The illustration above shows an undamaged hinge (1), and a damaged or bent hinge (2).
 - o If the hinge is NOT damaged, no repair is needed to the hinge. Proceed to the section titled, "Support Cable Replacement" and replace any support cables that HAD sealant in the earlier inspection. If neither of the support cables require replacement, no further action is required.
 - o If the hinge IS damaged or bent, the hinge needs to be replaced. Proceed to the section titled, "Hinge Replacement".

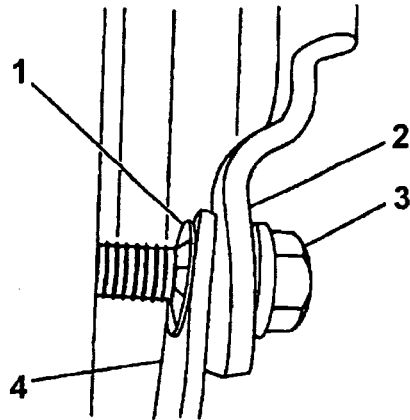
1466543

If the support cable (2) has NOT been replaced previously, there will be a toothed nut (1) located between the latch (4) and the tailgate that will prevent the bolt (3) from being removed in the next step. The nut is an assembly aid used in the assembly plant. The nut does NOT need to be reinstalled or replaced when installing a new support cable in this recall.
