Subject: 04007A - Product Safety Recall
Tailgate Support Cable
Parts Availability Update

Bulletin No.: 04007A

SUBJECT: TAILGATE SUPPORT CABLE

**MODELS: 2002-2004 CADILLAC ESCALADE EXT
2000 CHEVROLET CK
2000-2004 CHEVROLET SILVERADO
2002-2004 CHEVROLET AVALANCHE
2000-2004 GMC SIERRA**

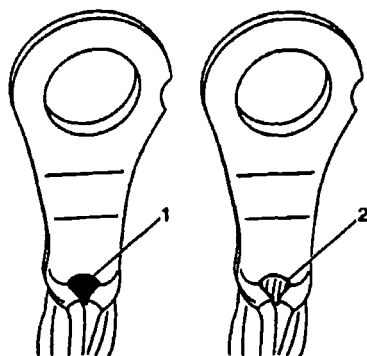
1545570

In the above illustration, the clear sealant (1) is shown as black in color. This was done for illustration purposes only. If sealant is present on the support cables it will be clear or hazy (cloudy) in appearance.

3. Inspect the end (eyelet) of the support cable that attaches to the tailgate for sealant covering the end of the cable strands.
 - o If there IS a clear type sealant (1) over the end of the cable strands, the support cable needs to be replaced. Reconnect the support cable to the pickup box and perform this same inspection on the left support cable. After inspecting both cables, proceed to the section titled, "Hinge Inspection."
 - o If there IS NOT a clear type sealant (2) over the end of the cable strands, that support cable does NOT need to be replaced. Reconnect the support cable to the pickup box and perform this same inspection on the left support cable. After inspecting both cables, proceed to the section titled, "Hinge Inspection."

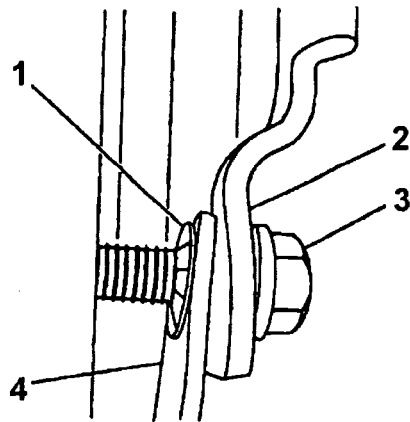
1466543

If the support cable (2) has NOT been replaced previously, there will be a toothed nut (1) located between the latch (4) and the tailgate that will prevent the bolt (3) from being removed in the next step. The nut is an assembly aid used in the assembly plant. The nut does NOT need to be reinstalled or replaced when installing a new support cable in this recall.
