**GM SERVICE AND PARTS OPERATIONS
DCS1489
URGENT - DISTRIBUTE IMMEDIATELY**

Subject: Product Safety Recall Bulletin 04007B
Tailgate Support Cable
Addition to Involved Vehicle Population

Bulletin No.: 04007B

SUBJECT: TAILGATE SUPPORT CABLE

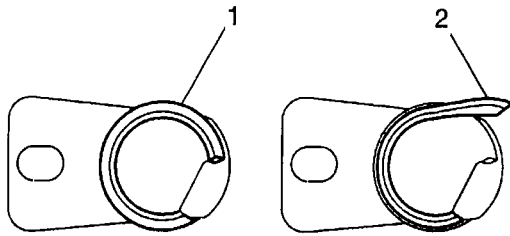
1553673

3. With the right side of the tailgate disengaged from the pickup box, inspect the hinge on the right side of the tailgate for damage. The illustration above shows an undamaged hinge (1) and a damaged or bent hinge (2).
 - If the hinge is undamaged (1), no repair is needed to the hinge. Proceed to the section titled, "Support Cable Replacement", and replace both support cables.
 - If the hinge IS damaged or bent (2), the hinge needs to be replaced. Proceed to the section titled, "Hinge Replacement", before proceeding with the replacement of the support cables.
