**GM SERVICE AND PARTS OPERATIONS  
DCS1489  
URGENT - DISTRIBUTE IMMEDIATELY**

Subject: Product Safety Recall Bulletin 04007B  
Tailgate Support Cable  
Addition to Involved Vehicle Population

Bulletin No.: 04007B

**SUBJECT:** TAILGATE SUPPORT CABLE

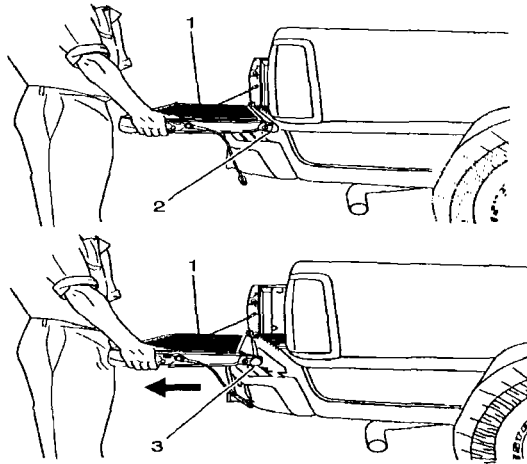
1538695

1. Release (unhook) the RIGHT side tailgate support cable from the pickup box.
2. With the tailgate (1) completely open as shown in the upper part of the illustration, pull the RIGHT SIDE of the tailgate rearward as shown in the lower illustration. Do not pull on the left side of the tailgate.
  - If the tailgate hinge (2) will NOT disengage from the pickup box on the right side, no repair is needed to the hinge. Proceed to the section titled, "Support Cable Replacement", and replace both support cables.
  - If the tailgate hinge (3) WILL disengage from the pickup box on the right side, proceed to the next step.

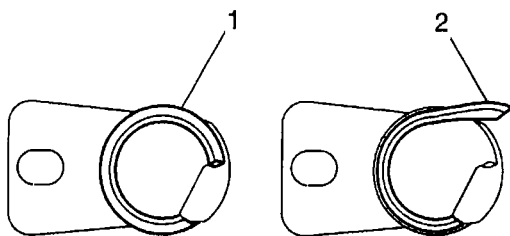
1553673

3. With the right side of the tailgate disengaged from the pickup box, inspect the hinge on the right side of the tailgate for damage. The illustration above shows an undamaged hinge (1) and a damaged or bent hinge (2).
  - If the hinge is undamaged (1), no repair is needed to the hinge. Proceed to the section titled, "Support Cable Replacement", and replace both support cables.
  - If the hinge IS damaged or bent (2), the hinge needs to be replaced. Proceed to the section titled, "Hinge Replacement", before proceeding with the replacement of the support cables.

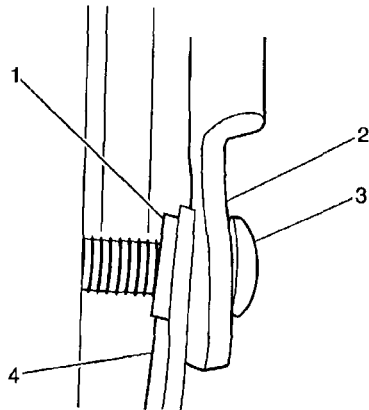
1551939

**Important:** If the support cable (2) has NOT been replaced previously, there will be a toothed nut or plastic nut (1) located between the latch (4) and the tailgate that MAY prevent the bolt (3) from being removed in the next step. The nut is an assembly aid used in the assembly plant. Do not reinstall or replace the toothed or plastic nut when installing the new support cable.

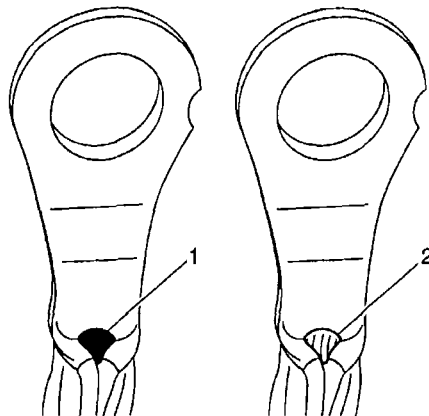
1545570

**Important:** In the above illustration, the clear sealant (1) is shown as black in color. This was done for illustration purposes only. If sealant is present on the support cables it will be clear or hazy (cloudy) in appearance.

3. Inspect the end (eyelet) of the support cable that attaches to the tailgate for sealant covering the end of the cable strands.
  - If there IS a clear type sealant (1) over the end of the cable strands, the support cable needs to be replaced. Reconnect the support cable to the pickup box and perform this same inspection on the left support cable. After inspecting both cables, proceed to the section titled, "Hinge Inspection."
  - If there IS NOT a clear type sealant (2) over the end of the cable strands, that support cable does NOT need to be replaced. Reconnect the support cable to the pickup box and perform this same inspection on the left support cable. After inspecting both cables, proceed to the section titled, "Hinge Inspection."

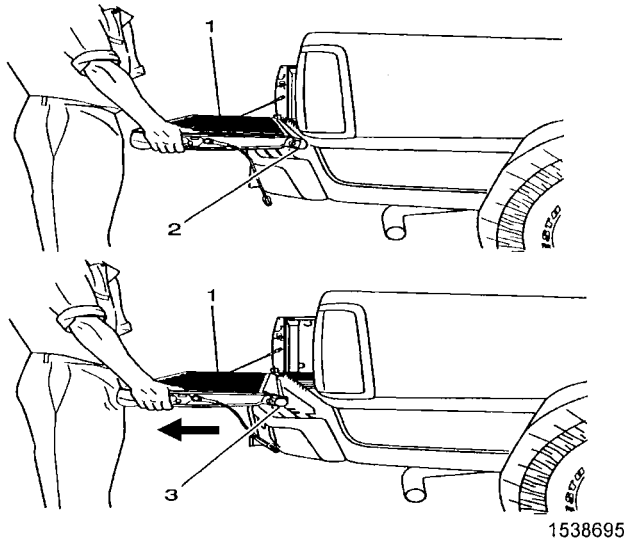
1. Release (unhook) the RIGHT side tailgate support cable from the pickup box again.
2. With the tailgate (1) completely open as shown in the upper part of the illustration, pull the RIGHT SIDE of the tailgate rearward as shown in the lower illustration. Do not pull on the left side of the tailgate.
  - If the tailgate hinge (2) will NOT disengage from the pickup box on the right side, no repair is needed to the hinge. Proceed to the section titled, "Support Cable Replacement," and replace any support cables that HAD sealant in the earlier inspection. If neither of the support cables require replacement, no further action is required.
  - If the tailgate hinge (3) will disengage from the pickup box on the right side, proceed to the next step.

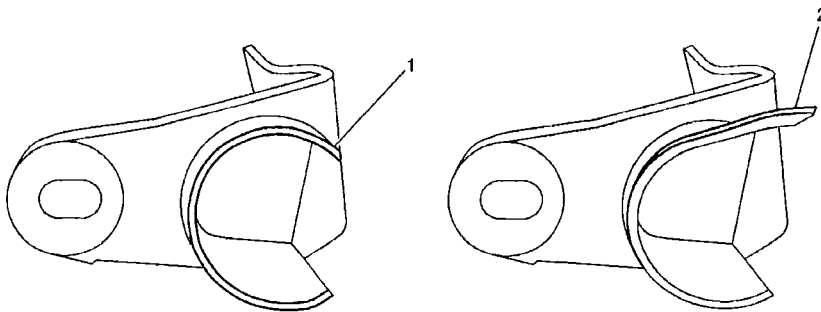
3. With the right side of the tailgate disengaged from the pickup box, inspect the hinge on the right side of the tailgate for damage. The illustration above shows an undamaged hinge (1), and a damaged or bent hinge (2).
  - If the hinge is NOT damaged, no repair is needed to the hinge. Proceed to the section titled, "Support Cable Replacement" and replace any support cables that HAD sealant in the earlier inspection. If neither of the support cables require replacement, no further

- If the hinge is damaged or bent, the hinge needs to be replaced. Proceed to the section titled, "Hinge Replacement".

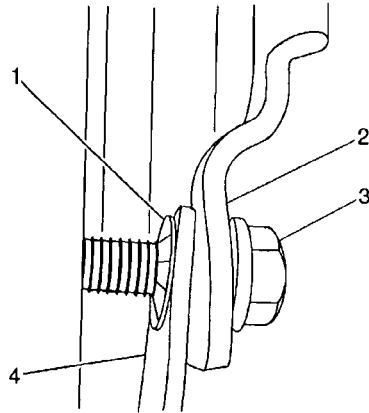
1466543

**Important:** If the support cable (2) has NOT been replaced previously, there will be a toothed nut (1) located between the latch (4) and the tailgate that will prevent the bolt (3) from being removed in the next step. The nut is an assembly aid used in the assembly plant. The nut does NOT need to be reinstalled or replaced when installing a new support cable in this recall.
