**Subject: Recall Campaign JC (04V-133)
1998 – 2004 Model Year A6/S6, 2003 R86 and
2001 – 2004 allroad quattro Vehicles
Install Plastic Cover on Driver's Side Support on Crossmember and Apply Felt to
Left Crossmember End**

Safety Recall Circular

Code: JC

**Subject: 1998–2004 Model Year Audi A6/S6, 2003 RS6 and
2001–2004 allroad quattro Vehicles
Install Plastic Cover On Driver's Side Support On Crossmember
and Apply Felt To Left Crossmember End**

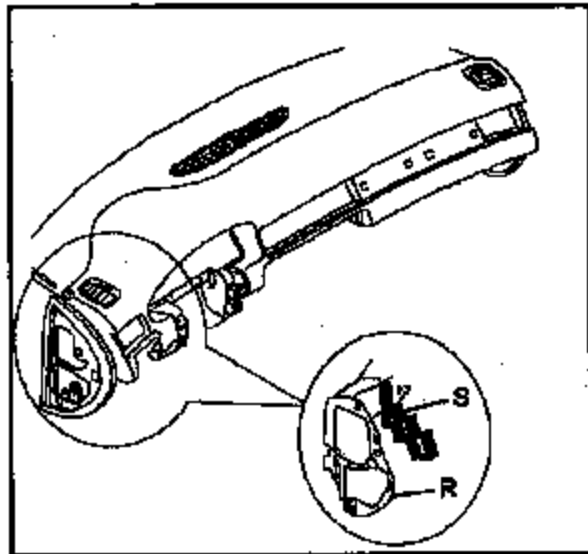
- ⇐ Locate support -S- (under headlight switch) and instrument panel crossmember end -R- (fuse panel is attached in lower hole)

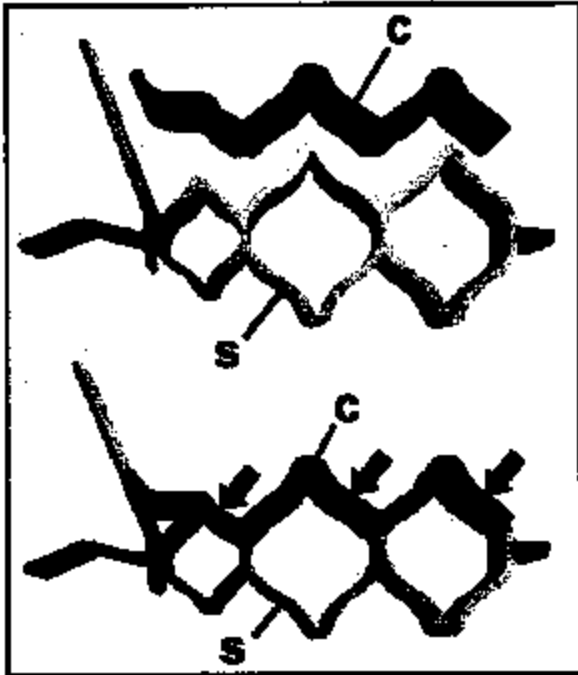
Edges of parts in the area may be sharp

⇐ Position new cover -C- (4B1 871 824 B) over support -S-

⇐ Press cover down -arrows- and snap fully into position on support as shown in illustration
