# Recall Bulletin

File In Section: Product Recalls  
Bulletin No.: 03030B  
Date: June 2004

**SUBJECT: REAR LIFTGATE LATCH ASSEMBLY**

**MODELS: 2002-2004 BUICK RENDEZVOUS**

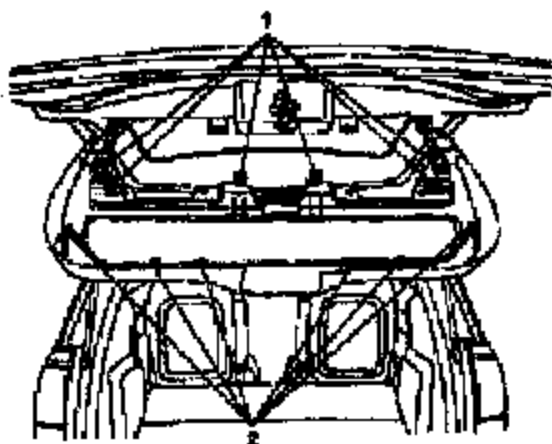
1375792

The illustration below shows the location of the twelve fasteners in the bottom section of the trim panel.

- 5.1 There are a total of twelve fasteners, six upper (1) and six lower (2), that must be released in order to "lower" the bottom section of the interior trim panel from the liftgate. The six upper retainers (1) must be released first.

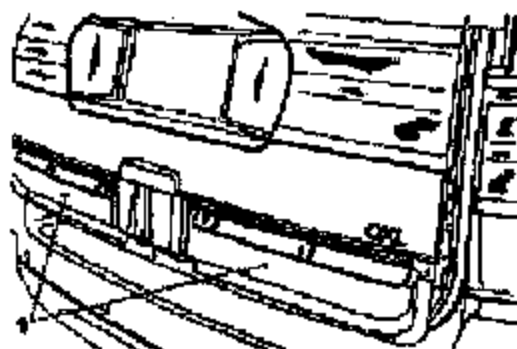
11. Once the liftgate lower molding has been removed, the section (1) of the liftgate where the reinforcement is to be installed can be seen.

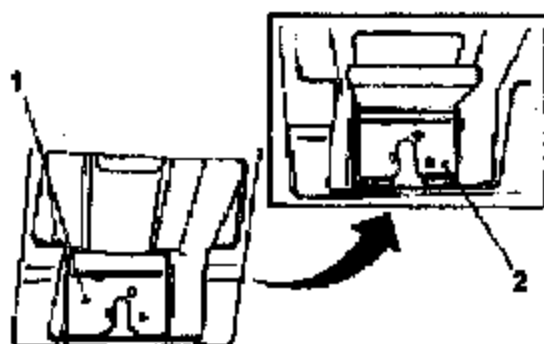
1337361

The above illustration shows the inside of the liftgate with the latch removed (1) and with the inner metal "Z" strap (2) installed.

16. Install the inner metal "Z" strap (2) as shown inside the opening in the liftgate where the latch is located.
17. While holding the "Z" strap in position, install the two bolts through the holes of the outer metal strap, the liftgate, and into the weld nuts on the "Z" strap. Align the outer metal strap to the liftgate. **Tighten**

Tighten the bolts to 10 N·m (89 lb in).
