**RE: SAFETY RECALL – 2003 FSC600/A Silver Wing Fuel Tank Inspection**

Bulletin Number	Page	File Behind Dealer Guide Bulletin Tab
04-0343	1 of 1	Service

## SAFETY RECALL

### 2004 CBR1000RR Inaccurate Speedometer

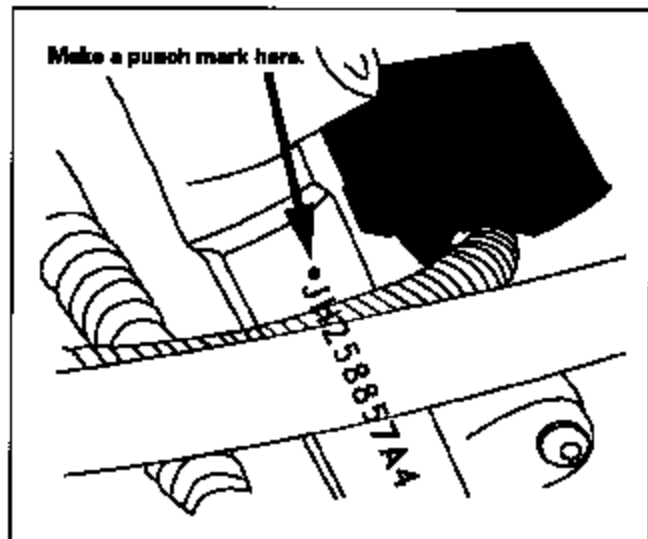
After you have completed the Replacement Procedure, make a punch mark in front of the first letter of the VIN as shown below.
