# TOYOTA CUSTOMER SERVICES

Volume: XI  
Number: TC04-007  
Date: 4/23/2004  
 Action  
 Retain  
 Information

SUBJECT: SPECIAL SERVICE CAMPAIGN (SSC) - 40B  
(2001 TO EARLY 2004 MODEL YEAR TOYOTA HIGHLANDER CHILD PROTECTION  
LOCK SYSTEM)

**TECHNICAL INSTRUCTIONS**  
**FOR**  
**SPECIAL SERVICE CAMPAIGN 40B**  
**2001 – EARLY 2004 MY TOYOTA HIGHLANDER**  
**CHILD PROTECTION LOCK SYSTEM**

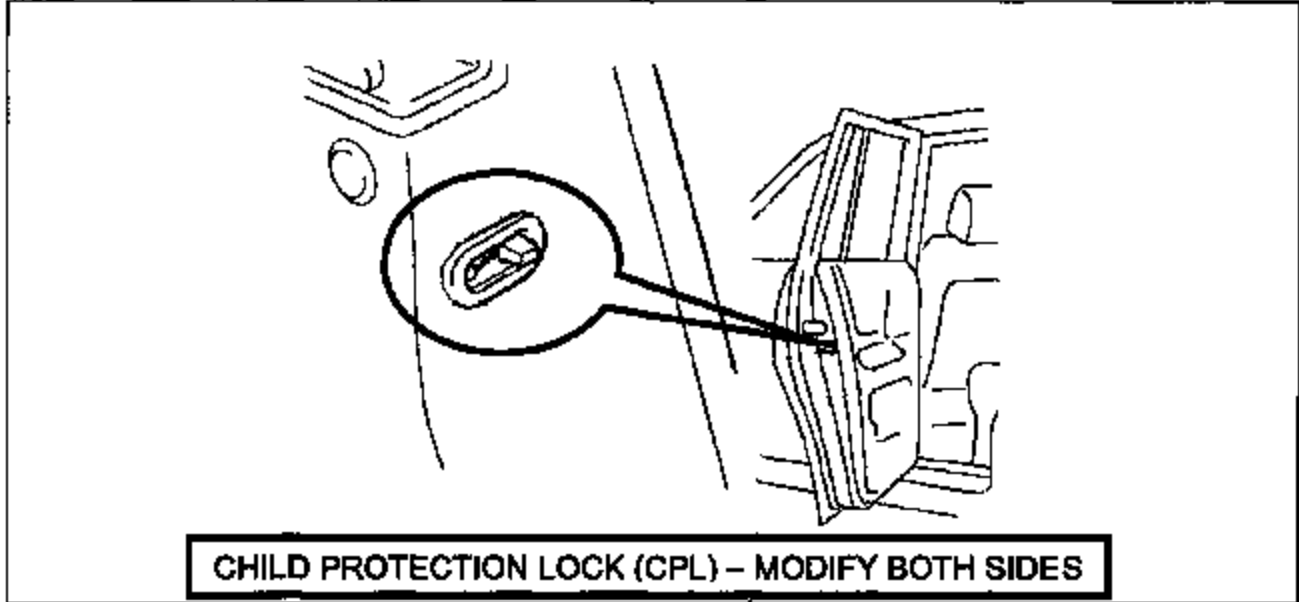
## II. LOCATION OF AFFECTED PARTS

A2: There is an insufficient amount of clearance between the CPL lever and the body panel.
