Recall Campaign 04V-182: Fuel Pump Resistor Retrofit

All E85 Z4 vehicles produced from February 2003 through October 2003.

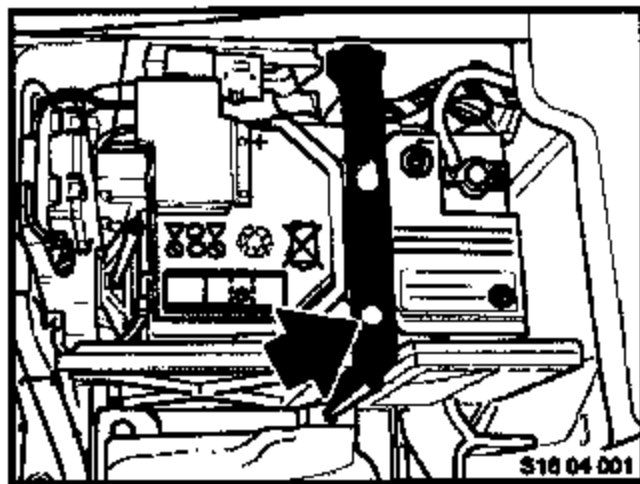
Remove luggage compartment floor to expose the battery. If there is a white sticker on the battery holder (see illustration), no further action is necessary. If there is no sticker, proceed with resistor installation.

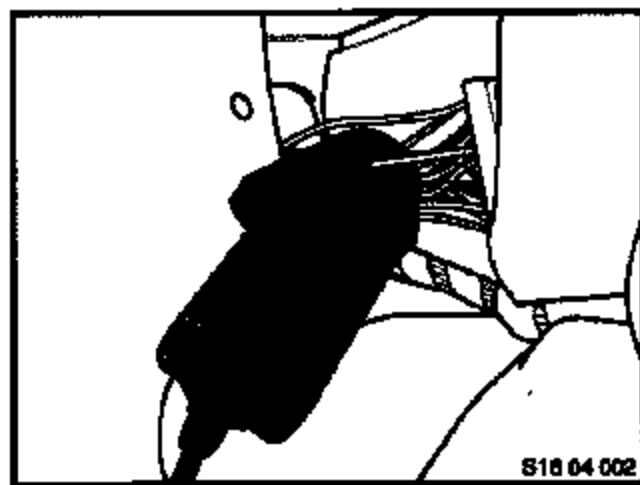
Remove the right side luggage compartment trim. Removal information can be found in Repair Instruction 51 47 161. Locate the comb connector fastened on a stud at the front right side of the luggage compartment.

Using the 50A current probe attached to the DISplus tester, clip the probe to one of the brown ground wires located near the center of the connector. Turn on the ignition. A 5-8 amp current flow should be observed for a few seconds. If so, the ground side of the fuel pump circuit has been located. If not, switch the probe to another nearby brown wire and retry. Switch off the ignition and wait approximately 10 seconds between attempts.
