Recall Campaign 04V-183, Install Retaining Clips on Front Spring Struts

E39 (5 Series)

Recall Campaign No. 04V-163: Front Strut Plate

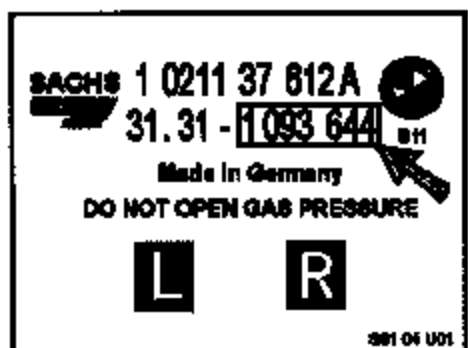
Note the part number of both front struts as shown by the arrow in the illustration. Compare the part numbers found on both front spring struts to the list below.

- If the part numbers on the front struts do not match the list above, no further action is required.
- If the part number of either front strut is listed above, fit the retaining clips on the front spring struts using the following procedure.
- If the part number of either front strut is missing or not legible, fit the retaining clips on the front spring struts using the following procedure.
