Reference: NHTSA Identification Number 04V-185

September 2004

## **Safety Recall D20 – ABS Wiring Corrosion**

**1998-2003 (AB) Dodge Ram Van/Wagon**

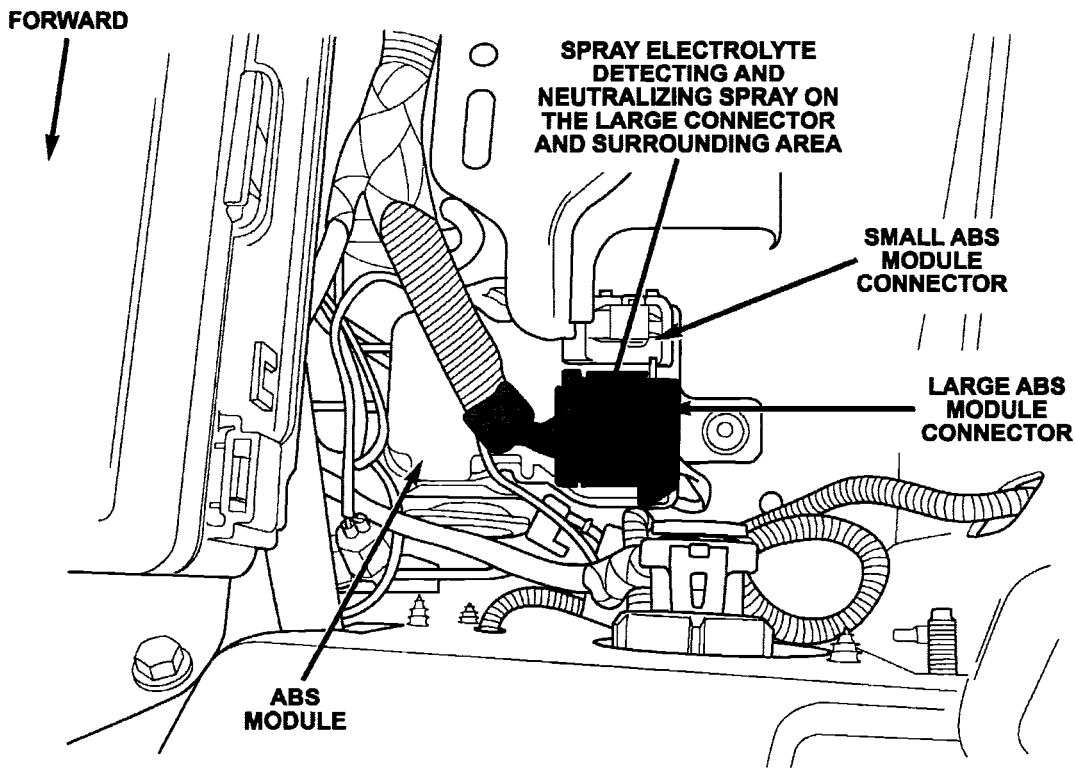
Figure 6

14. In the area below the battery location, inspect the front (large) wiring harness connector on the ABS control module for acid damage, by spraying the connector and surrounding area with the provided Electrolyte Detection and Neutralizing Spray (Figure 6).

- If the spray remains an orange color, there is no electrolyte (battery acid) on the ABS control module wiring harness connector. Continue with **Section E - Battery Tray Installation**.
- If the spray turns a purple color, continue with Step 15 of this procedure.

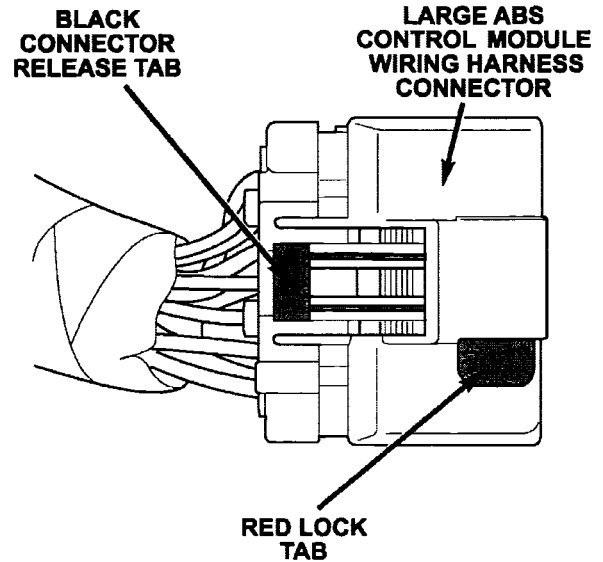
Figure 7

- If a heat damaged (melted) connector is found, replace the wiring harness connector. Continue with **Section C - ABS Control Module Wiring Harness Connector Replacement**. If no heat damage is found continue with inspection Step b.

- Inspect the wire side and the terminal side of the large ABS control module wiring harness connector for green colored corrosion. If green colored corrosion is found in one or more of the connector cavities continue with **Section C - ABS Control Module Wiring Harness Connector Replacement**. If no green colored corrosion is found, continue with inspection Step c.
- Looking into the terminal side of the large ABS control module wiring harness connector, inspect the metal terminals for a dull finish or discoloration. If a dull finish or discoloration is found, continue with **Section C - ABS Control Module Wiring Harness Connector Replacement** because the original connector housing wire weather seals have been damaged. If no dull or discolored terminals are found continue with **Section E - Battery Tray Installation**.

15. Disconnect the large ABS control module wiring harness connector from the ABS control module by first sliding the red lock tab forward. Then push down on the black release tab while pulling the connector from the module (Figure 7).

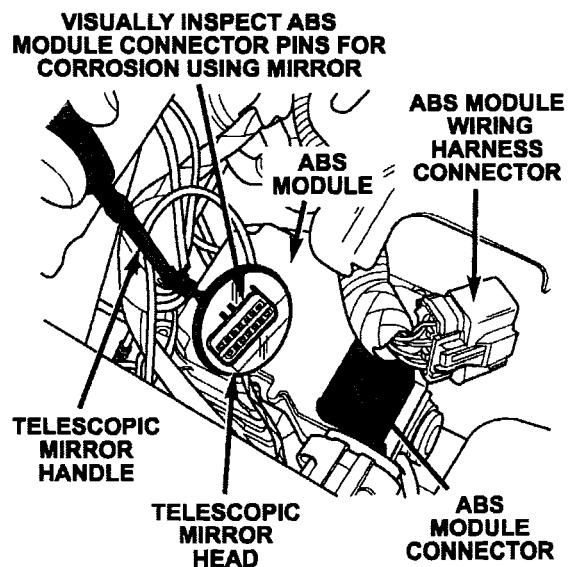
Figure 12

6. Using a small mirror (Snap-on GA295 or equivalent), inspect the ABS control module connector pins for green corrosion and the connector housing for heat damage (Figure 12).

- ABS control module connectors found **with** green corroded pins continue with **Section D - ABS Control Module Replacement**.
- ABS control module connector housings found **with** heat damage continue with **Section D - ABS Control Module Replacement**.
- ABS control module connectors found **without** heat damage or green corroded pins continue with **Section E - Battery Tray Installation**.
