SUBJECT:		No: SR-04-004	
TRAILER HITCH WIRING HARNESS — SAFETY RECALL CAMPAIGN		DATE: May, 2004	
		MODEL: See below	
CIRCULATE TO:	<input checked="" type="checkbox"/> GENERAL MANAGER	<input checked="" type="checkbox"/> PARTS MANAGER	<input checked="" type="checkbox"/> TECHNICIAN
<input checked="" type="checkbox"/> SERVICE ADVISOR	<input checked="" type="checkbox"/> SERVICE MANAGER	<input checked="" type="checkbox"/> WARRANTY PROCESSOR	<input checked="" type="checkbox"/> SALES MANAGER

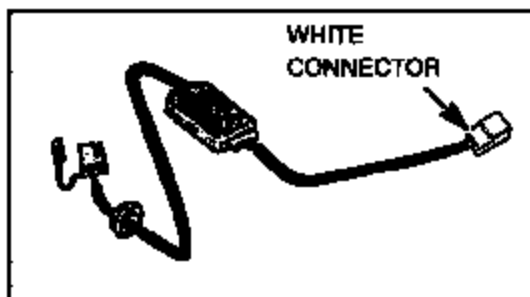
The Mitsubishi Genuine Accessory trailer hitch wiring harness optionally used on affected vehicles may overheat as a result of a high current draw from the trailer lamp circuit. Replace the trailer hitch wiring harness with the new, redesigned harness kit listed in the PARTS INFORMATION section of this bulletin.

1. Verify the trailer hitch wiring harness is the harness shown here. Replace the harness, using the appropriate new parts listed in the PARTS INFORMATION section of this bulletin. Refer to the installation instructions provided with the new harness.
2. Verify the new harness works properly.
