Campaign No. 2004070010, October 2004
 Revised November 2005

TO: ALL MERCEDES-BENZ CENTERS

SUBJECT: **MODELS 215/220, MODEL YEARS 2000 THROUGH 2001
 INSTALLATION OF BLOWER MOTOR WIRING HARNESS**

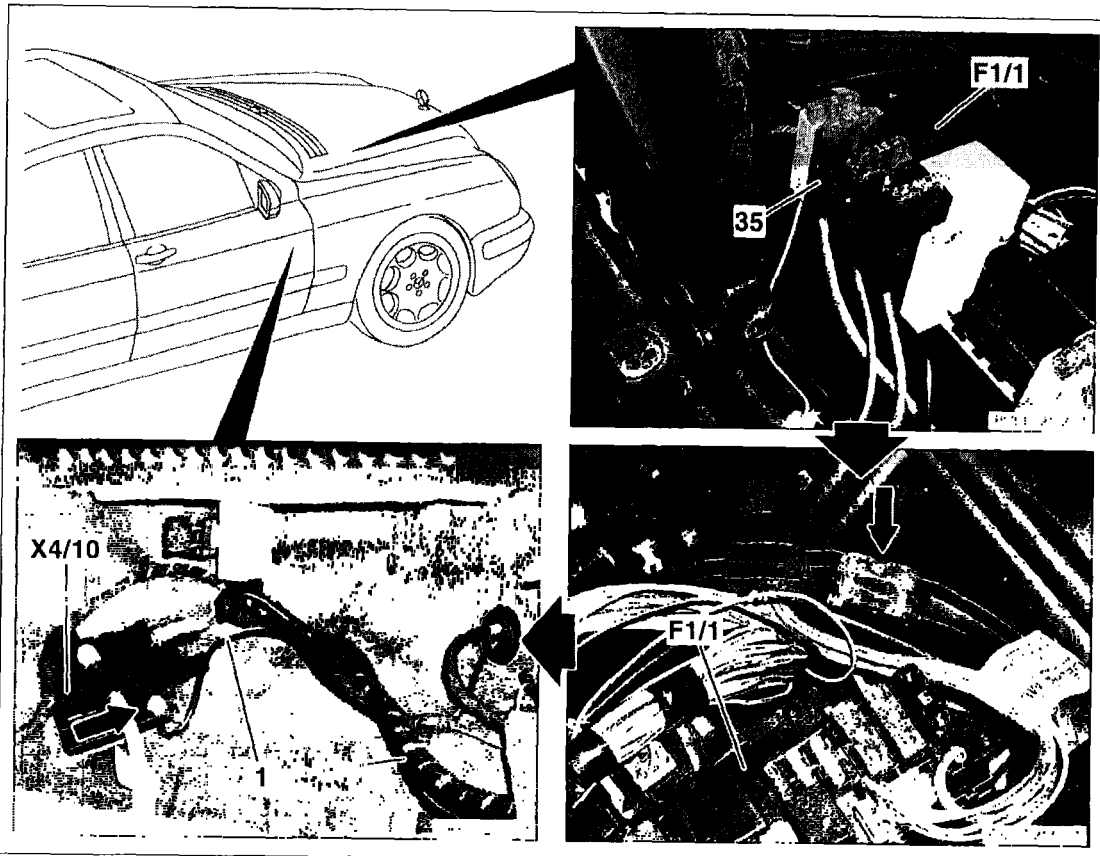
**Figure 1**

X4/10 Terminal block and fuse box, terminal 30
 F1/1 Right fuse box

A. PRELIMINARY WORK

1. Disconnect battery ground cable WIS: AR54.10-P-0003I.

2. Remove right front floor covering WIS: AR68.20-P-2070M.

3. Remove right front foot support.
4. Lift up right front SAM (WIS: AR54.21-P-1261I) to gain access to harness opening in bulkhead.
