Campaign No. 2004070010

October 2004

TO: ALL MERCEDES-BENZ CENTERS
 SUBJECT: **MODELS 215/220**
MODEL YEARS 2000 THROUGH 2001
INSTALLATION OF BLOWER MOTOR WIRING HARNESS

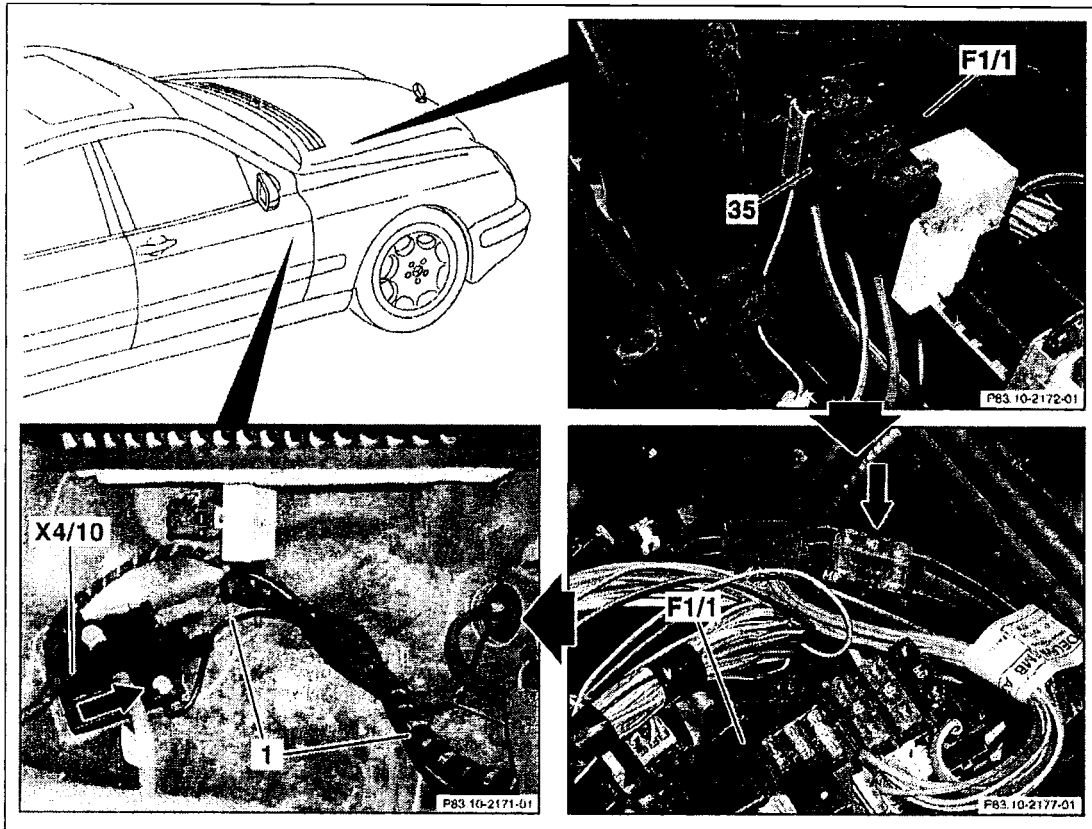
Figure 1

X4/10 Terminal block and fuse box, terminal 30
 F1/1 Right fuse box
