VEHICLE RECALL

G-04509

September 2004

**SUBJECT: SAFETY RECALL (U.S., EXPORT)
POWER STEERING PUMP MOUNTING STUDS on
certain 1652SC, 3800, 4700SFC, RE and CE bus
models built 2/04/2003 thru 2/27/2004 with T444E
engines.**

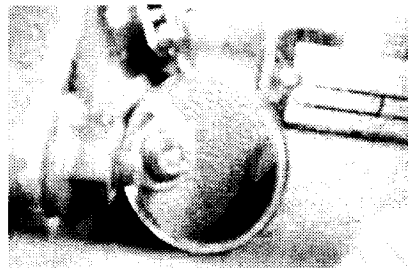
Figure 1

1. Open and secure hood.
2. Using a dental mirror, inspect the end of the studs for any manufacturer's marks.

3. If the mounting studs contain either of the following marks on the ends of the stud, **THEY MUST BE REPLACED**. Skip to step 5 for replacement procedure.
