RE: 04V-255

Applies To: **2002-03 CR-V** - All VINs beginning with "SHSRD"**June 21, 2004****2004 CR-V 2WD** - From VIN SHSRD68...4U200001 thru SHSRD68...4U206096**2004 CR-V 4WD** - From VIN SHSRD7...4U200001 thru SHSRD7...4U238165**Safety Recall: CR-V SRS Cable Reel Connector****BACKGROUND**

**Safety Recall:  
CR-V SRS Cable Reel Connector**

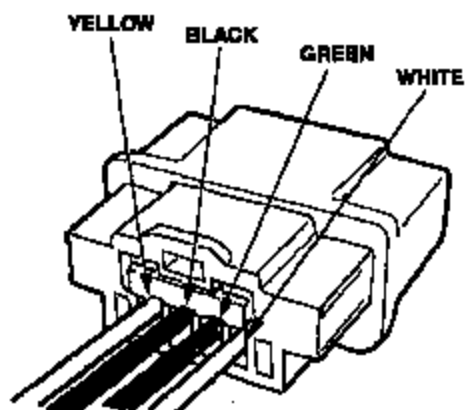
**CORRECT:**

7. Inspect the wire order going into the cable reel connector. With the connector positioned as shown below, the wire order, left to right, should be YELLOW, BLACK, GREEN, WHITE.

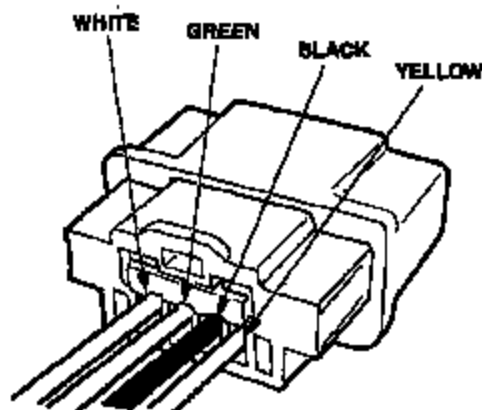
**INCORRECT:**

The wire harness of the driver's front airbag was incorrectly wired. During specific crash conditions, the airbag inflation rate is incorrect, which could increase the risk of injury to the driver.

- If the wires are in the correct order, or if they are all the same color, go to step 14.
- If the wires are not in the correct order, go to step 8.

Replace the SRS cable reel 4P connector, and reposition the cable reel connector wires.
