Reference: NHTSA Identification Number 04V-268

Safety Recall #18 **Power Steering Pressure Hose**

2001-2004 (PT) Chrysler PT Cruiser

2005 (PT) Chrysler PT Cruiser Convertible

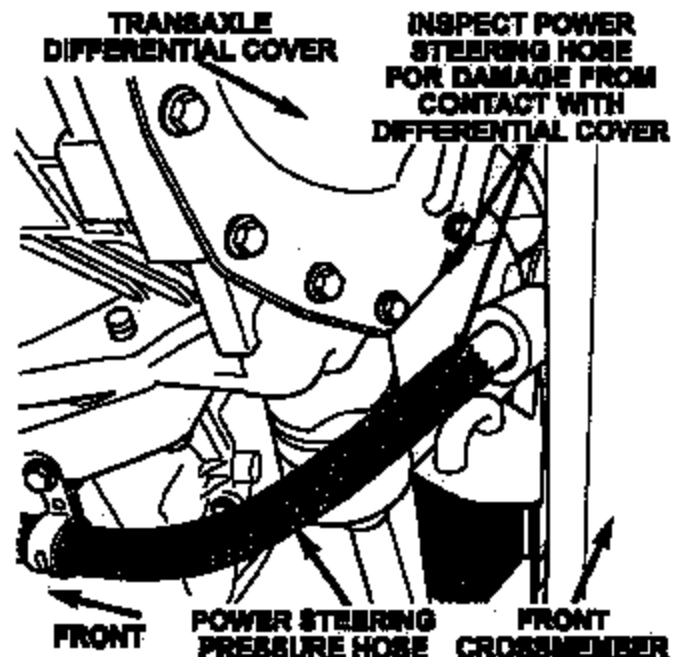
Figure 2

1. Raise the vehicle on an appropriate hoist.
2. Inspect the section of power steering pressure hose closest to the transaxle differential cover (near the left rear of the engine) (Figure 2).
3. > **If the power steering hose is cut or worn such that the hose reinforcement cords are visible**, the power steering hose must be replaced. Continue with **Section B. – Replace Power Steering Pressure Hose**.
- > **If the hose section of the power steering hose is NOT cut or worn, or if the hose reinforcement cords are not visible**, continue with Step 4.
4. Mark the location on the power steering hose of the two (2) clamps that secure the power steering hose to the rear of the engine (Figure 3).
