Re: Defect Information Report (FL-424), NHTSA no. 04V-272

Section 573.6 Defect Information Report
FL-424, NHTSA no. 04V-272
Supplement No.: 1

Subject: Medium Duty Front Axles with Four-Piece Spindle Nut Sets

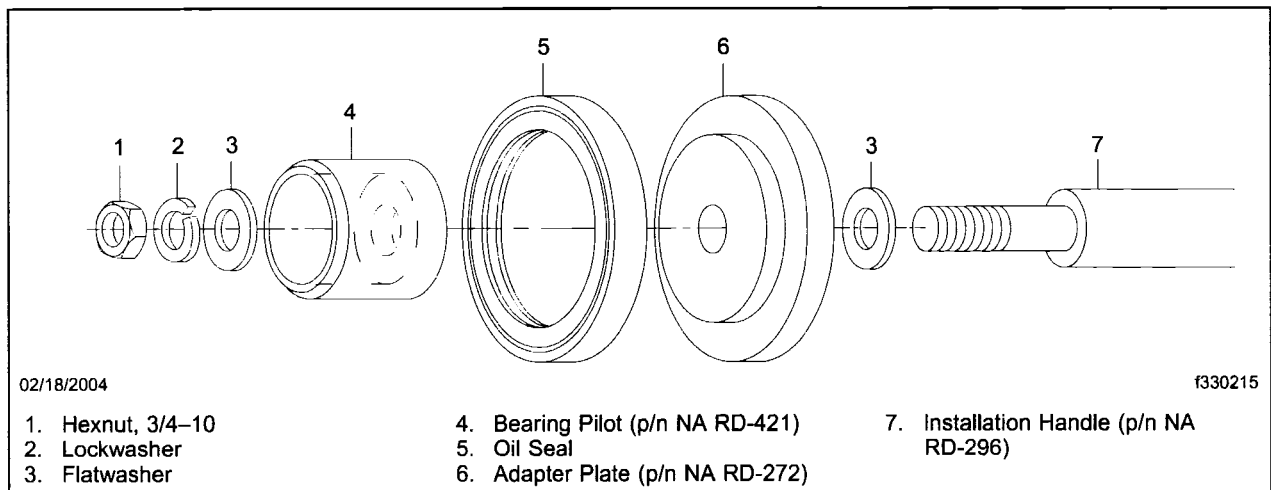
Fig. 3, National Oil Seal and Installation Tools

NOTE: The oil seals in the kit are National[®] oil seals. Special installation tools for these seals are available from the PDCs. See Fig. 3.

- 4.1 Put a light coating of gear oil on the inner and outer surfaces of the new oil seal.
- 4.2 If using a press, put the hub onto a centering fixture, inboard side up.
If you are manually installing the oil seal, make sure the hub is on a firm, level surface (inboard side up).
- 4.3 Install the adapter plate and bearing pilot onto the steel handle using the hexnut and washers provided. See Fig. 3.
- 4.4 Put the oil seal onto the adapter plate, making sure the words "Air Side" on the oil seal are facing the adapter plate surface.
- 4.5 Making sure the oil seal is aligned straight with the hub bore, install it into the hub. See Fig. 4.
- 4.6 If using a press, press the oil seal into the hub.
If manually installing the seal, strike the end of the installation tool with a heavy mallet. Continue striking until the sound changes.
- 4.7 Wipe off any excess oil from the face of the oil seal.

NOTE: When the oil seal is correctly installed in the hub bore, the face of the seal (the side with the words "Air Side") should be flush with the face of the hub.

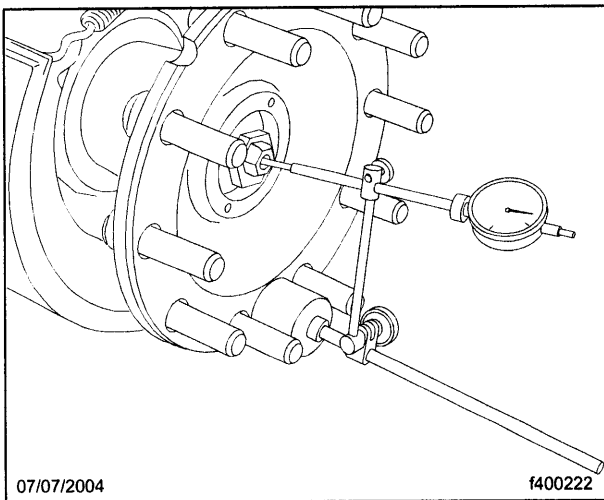
Fig. 5, Using the Dial Indicator

IMPORTANT: The end play must be between 0.001 and 0.005 inch (0.025 and 0.127 mm). This is crucial to the life of the wheel bearings.

8.5 With the jam nut installed and tightened, attach a dial indicator to the hub and set the point of the indicator in line with the end of the axle spindle. See Fig. 5.

Grip the sides of the hub at the 3 o'clock and nine o'clock positions. Push the hub (and drum, if applicable) to seat the inboard bearing set. Zero the dial indicator.

Grip the sides of the hub at the 3 o'clock and 9 o'clock positions. Pull the hub (and drum, if applicable). Read the dial indicator and note the end play.

If the end play is not within the correct range, remove the jam nut and locking device and back off or tighten the inner (adjusting) nut to adjust the end play.

Install the locking device and jam nut as described earlier and measure the end play. If the end play is not between 0.001 and 0.005 inch (0.025 and 0.127 mm), readjust the inner (adjusting) nut.
