Subject: 04043A \ Revised Product Safety Recall
Lower Control Arm Washer

Models: 2004 Cadillac CTS, SRX and XLR
2004 Chevrolet Corvette

File in Section: Product Recalls
Bulletin No.: 04043A
Date: September 2004

SUBJECT: LOWER CONTROL ARM WASHER

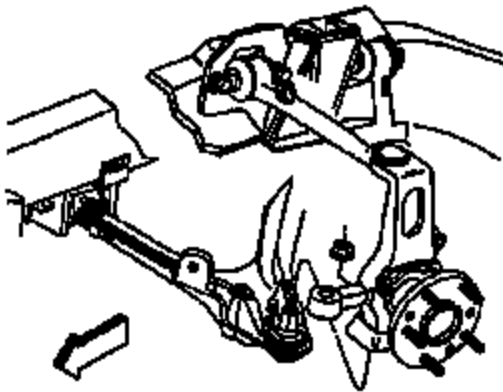
168544

LOWER CONTROL ARM NUTS THAT NEED TO BE INSPECTED	
MODEL	INSPECTION
2004 Cadillac CTS and SRX	Both left and right FRONT lower ball joint stud to the steering knuckle.
2004 Cadillac XLR and Chevrolet Corvette	Both left and right FRONT <u>AND</u> REAR lower ball joint stud to the steering knuckle
