Subject: 04043B - Product Safety Recall
Lower Control Arm Washer
Parts Ordering Update

Models: 2004 Cadillac CTS, SRX and XLR
2004 Chevrolet Corvette

File In Section: Product Recalls
Bulletin No.: 04043B
Date: November 2004

SUBJECT: LOWER CONTROL ARM WASHER

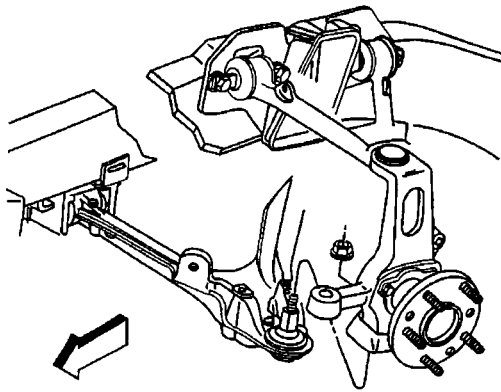
168544

The following procedure provides instructions for inspecting and replacing the nut that attaches the lower ball joint stud to the knuckle. In a few instances, the results of the inspection may determine that the lower control arm and knuckle need replacement.

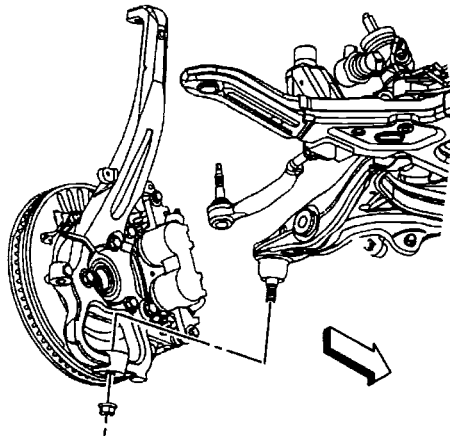
1209265

LOWER CONTROL ARM NUTS THAT NEED TO BE INSPECTED	
MODEL	INSPECTION
2004 Cadillac CTS and SRX	Both left and right FRONT lower ball joint stud to the steering knuckle.
2004 Cadillac XLR and Chevrolet Corvette	Both left and right FRONT <u>AND</u> REAR lower ball joint stud to the steering knuckle
