Re: 49 CFR Part 573; Recall of Mercedes-Benz S and CL-Class

NHTSA Recall Number  
04V-285

Campaign No. 2004050015  
August 2004

**SUBJECT:** MODELS 215, 374/375/376, 220, 170/175/174/176/183/184  
MODEL YEARS 2003 AND 2004  
(WITHOUT OPTION CODE 681: REMOTE TRUNK LID CLOSING)  
REPLACEMENT OF BOTH TELESCOPING SPRINGS ON TRUNK LID

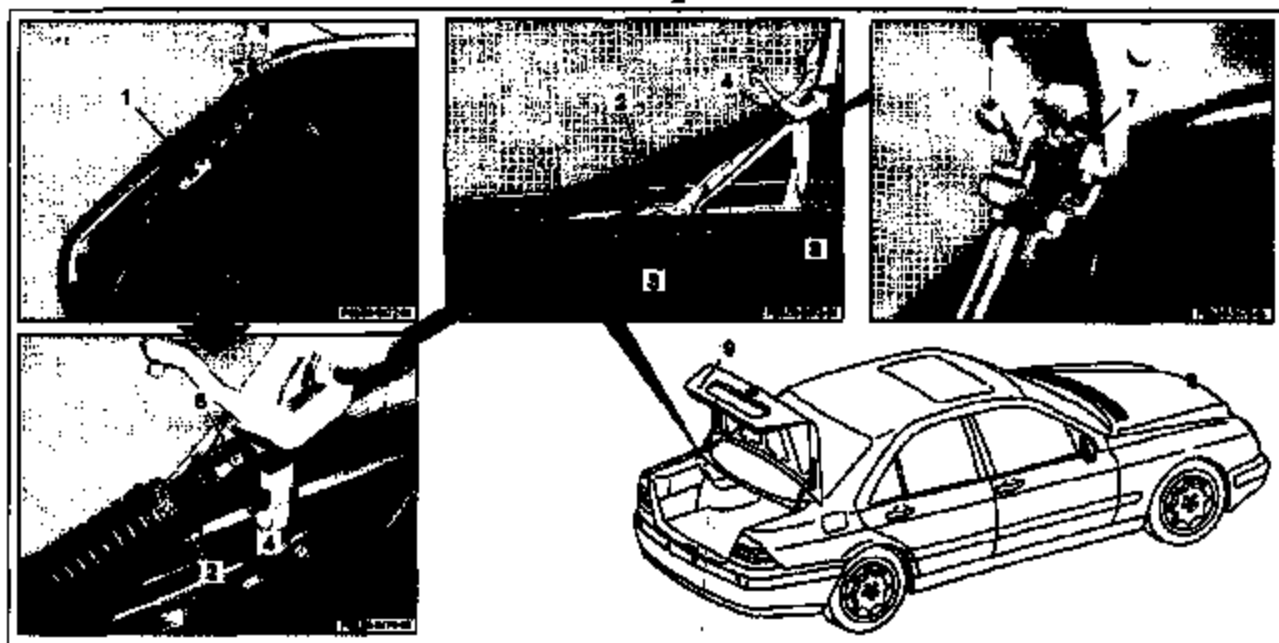
This Recall Campaign has been initiated because DCAQ has determined that on affected vehicles (see VIN range below), the trunk lid springs could fail in the closed trunk lid position due to extensive exposure to very high temperatures. This failure only occurs in the closed position and causes the trunk lid to fail to spring open upon being unlocked, thereby providing notice to the customer of the broken spring condition. Nevertheless, if the trunk lid is manually lifted, it may not remain in the up position and could potentially cause injury if it comes down while someone is reaching into the trunk. We therefore advised customers, in the Recall letter, to hold open the trunk lid, during use of the trunk, until the repair is completed. The recall will be conducted in order to replace both trunk lid springs with improved springs of increased strength.

### Procedure (replacement of both telescoping springs)

#### A. Removal of telescoping spring

1. Open trunk lid (9).
2. Insert trunk support tool (special tool: W170 589 04 6300). Do not tighten thumbscrew on support tool (slight movement of trunk lid is required for spring installation).

3. Remove spring cover (1).
4. Pivot trunk lid (9) slightly downward until stop buffer (7) is accessible.
5. Unclip stop buffer (7) from right and left hinge lever.
6. Carefully open trunk lid (9) up to mechanical end stop (telescoping spring [2] is now free of tension).
7. Unlock retaining spring (8) on ball socket head (4).
8. Remove ball socket head (4) from hinge lever and unhook telescoping spring (2) at bottom, note position.

#### B. Installation of new telescoping spring

2. Hook new telescoping spring (2) in at bottom and press ball socket head (4) onto hinge lever (an audible click will be heard when ball socket is properly engaged).
3. Lock retaining spring (8) onto ball socket head (4).

4. Pivot trunk lid (9) downward.
5. Reinstall stop buffer (7) into left and right hinge lever (ensure stop buffer is completely seated).
6. Reinstall spring cover (1).
7. Remove trunk lid (8) support (special tool: W170 589 04 6300).
8. Close trunk lid (9).
