Subject: 04048A \ Revised Product Safety Recall
Electronically Controlled Air Suspension/Powertrain Control Module

Models: 2002 GMC Envoy
2002 Oldsmobile Bravada
Equipped with Electronically Controlled Air Suspension (RPO G67)

File In Section: Product Recalls
Bulletin No.: 04048A
Date: September 2004

SUBJECT: ELECTRONICALLY CONTROLLED AIR SUSPENSION/POWERTRAIN CONTROL MODULE

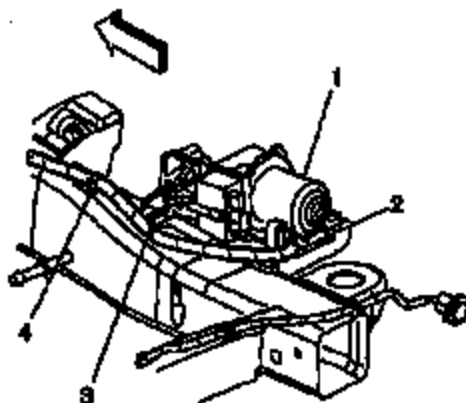
747616

When disconnecting the electrical connector in the next step, the grey colored terminal cover inside the harness connector may remain in the connector on the ECAS compressor. If this occurs, the new jumper harness cannot be connected to the compressor until the grey cover is removed.

2. Locate and disconnect the eight-way electrical connector (2) from the ECAS compressor (1).
3. Connect one end of the new jumper harness to the connector on the ECAS compressor.
4. Connect the other end of the jumper harness to the connector on the vehicle harness.
5. Secure the new jumper harness to the original vehicle wiring harness using the plastic tie strap.
6. Lower the vehicle.
