**Subject: 04055 Product Safety Recall  
Front Frame Rear Body Mount Bracket Fracture**

**Models: 2004 Pontiac Grand Prix**

Bulletin No.: 04055

**SUBJECT: FRONT FRAME REAR BODY MOUNT BRACKET FRACTURE**

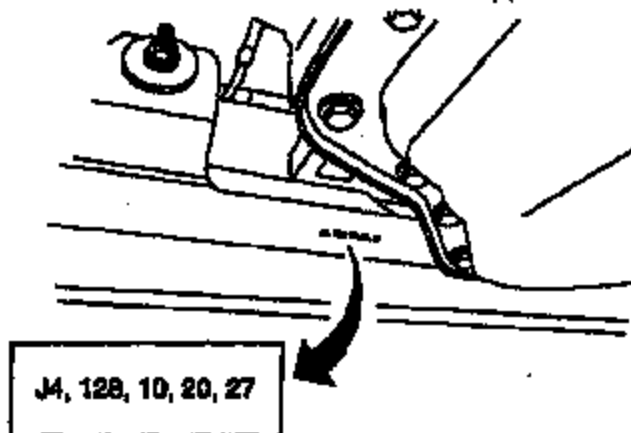
1626586

2. Locate the date code stamped on the frame assembly near the transmission pan as shown. For this inspection we are looking for frames made during a certain timeframe on one particular day this year.

The date codes involved are J4, 128, 10, 20, 27 to J4, 128, 13, 25, 54.

- "DAY" Begin with the Day number. If the "day" number in the date code is not 128, the frame does NOT need to be replaced. If the "day" number is 128, proceed to the next step and inspect the "hour".
- "HOUR" If the "hour" number in the date code is 9 or less, or 14 or higher, the frame does NOT need to be replaced. If the number on the frame is 11 or 12, the frame must be replaced. If the number is 10 or 13, proceed to the next step and inspect the "minute".
- "MINUTE" If the "hour" number is 10 and the "minute" number in the date code is 19 or less, then the frame does NOT need to be replaced. If the "minute" number on the frame is 21 or higher the frame must be replaced. If the "minute" number is 20, then continue and inspect the "second".

- "MINUTE" If the "hour" number is 13 and the "minute" number in the date code is 24 or less, the frame must be replaced. If the "minute" number on the frame is 26 or higher the frame does NOT need to be replaced. If the "minute" number is 25, then proceed to the next step and inspect the "second".
- "SECOND" If the "minute" number is 20 and the "second" number in the date code is 26 or less, the frame does NOT need to be replaced. If the "second" number is 27 or higher, the frame must be replaced.

- "SECOND" If the "minute" number is 25 and the "second" number in the date code is 54 or less, the frame must be replaced. If the "second" number is 55 or higher, the frame does NOT have to be replaced.
