Subject: 04056 - Noncompliance Recall
Passenger-Side Rear Safety Belt Anchorage Compliance

Models: 2004 Chevrolet Cavalier
2004 Pontiac Sunfire

File In Section: Product Recalls
Bulletin No.: 04058
Date: August 2004

SUBJECT: PASSENGER-SIDE REAR SAFETY BELT ANCHORAGE COMPLIANCE

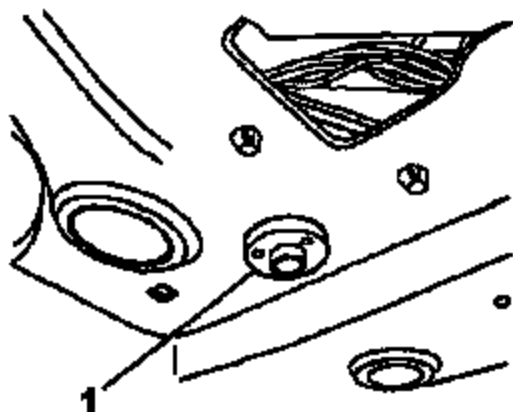
1538474

2. From inside the trunk, reposition the trim and locate the weld nut (1) that attaches the RIGHT rear shoulder belt retractor to the rear panel.
3. Reposition the trim on the opposite side and locate the weld nut that attaches the LEFT rear shoulder belt retractor to the rear panel.
4. Measure and compare the outside diameter of the RIGHT and LEFT weld nuts or, measure and compare the diameter of the bolt holes to each other.
 - If the RIGHT side (diameter or hole) is about 2 mm (1/16 in) SMALLER than the left side (diameter or hole), the RIGHT side weld nut and bolt must be replaced. Proceed to the section titled, "Weld Nut and Bolt Replacement."
 - If the RIGHT side (diameter or hole) is the SAME size as the left side (diameter or hole), NO repair is required. Reposition the trim and close the rear compartment lid.

This replacement procedure should only be performed if the results of the inspection procedure indicate that the replacement of the weld nut and bolt is required. Perform this procedure only if the diameter is 2 mm (1/16 in) smaller on the RIGHT side.
