**Subject: 04044 - Noncompliance Recall
Park Lock Cable Assembly**

Recall Bulletin

File In Section: Product Recalls
Bulletin No.: 04044
Date: August 2004

SUBJECT: PARK LOCK SYSTEM COMPLIANCE

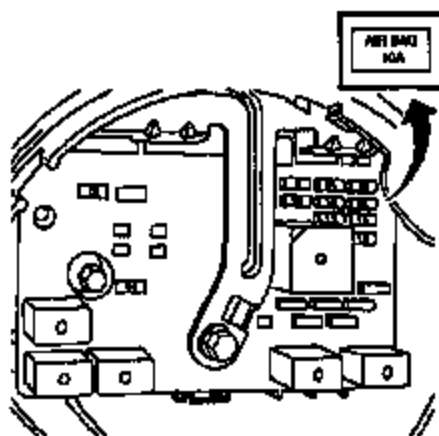
1308912

1. Locate the fuse center on the forward right side of the floor console and remove the cover.

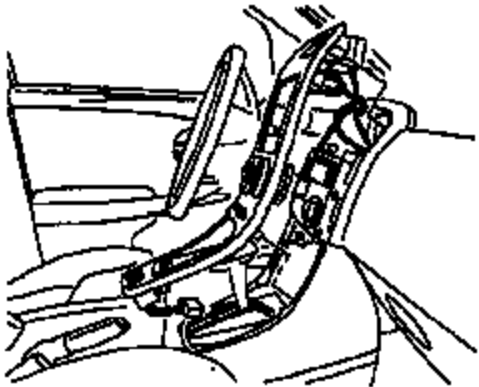
1347010

4. Starting at the bottom, carefully pull to disengage the trim bezel retainers from the floor console.

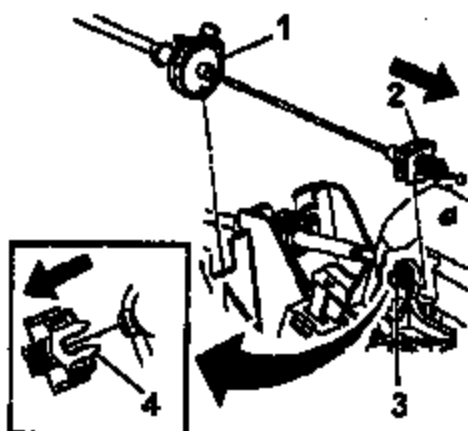
1537829

10. Locate the orange retaining ring (1) that attaches the park lock cable to the shift control. Squeeze the two tabs on the orange retaining ring together and pull upward to remove the park lock cable from the shift control.
11. Place the shift lever in the PARK position and remove the key from the Ignition.
12. Reaching under the front of the shift assembly, disconnect the park lock cable retainer (2) from the shift lever by pushing the end of the cable rearward to disengage the slot (4) from the pin (3).
13. With the park lock cable disconnected from the shifter, reposition the cable to obtain access to the cable end.

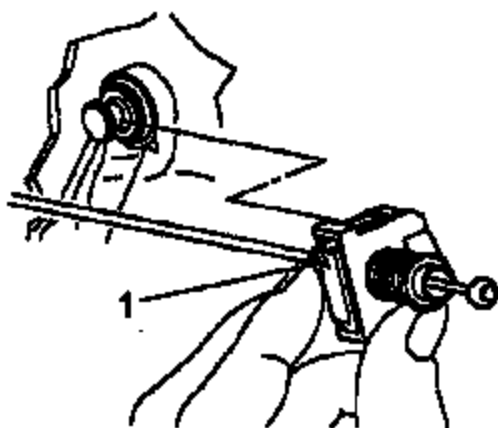
1537827

14. Using a small flat-bladed screwdriver, carefully pry up the locking retainer (1) in the cable retainer.
15. Position the cable and orange retaining ring back into the shifter control and push down to seat the ring.
