SI B13 01 04
Fuel SystemsJuly 2004
Technical Service

Recall Campaign 04V-■ 303: Retaining Clip Retrofit for the Fuel Line Quick Release Coupling

E60 (5 Series) and E63/64 (6 Series) with the N62 engine from September 2003 through March 2004

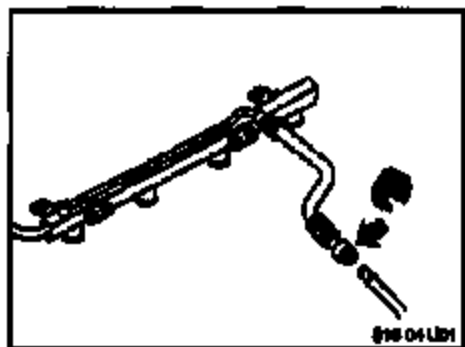
A retaining clip securing the fuel line quick release coupling was inadvertently omitted in the listed models. In the event of a severe head-on collision, the quick release coupling could become disconnected. This would result in a small amount of fuel being released, which, in an extreme case, could potentially ignite.

Snap the new retaining clip to the quick release coupling as shown in the illustration.
