Subject: 04061 Product Safety Recall
Transmission Shift Cable Separation

Models: 2004 Chevrolet Express
2004 GMC Savana

File In Section: Product Recalls
Bulletin No.: 04061
Date: August 2004

SUBJECT: TRANSMISSION SHIFT CABLE SEPARATION

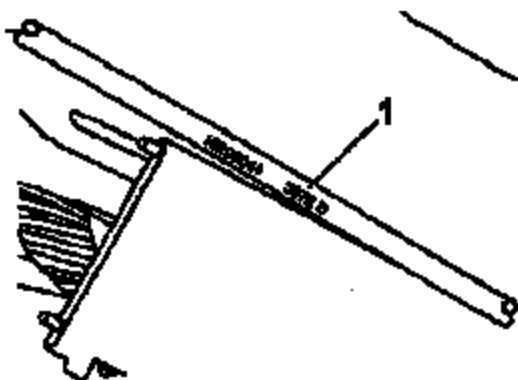
1530604

3. Pull the driver's side carpet down and rearward to expose the floor pan, transmission, and shift cable (1).

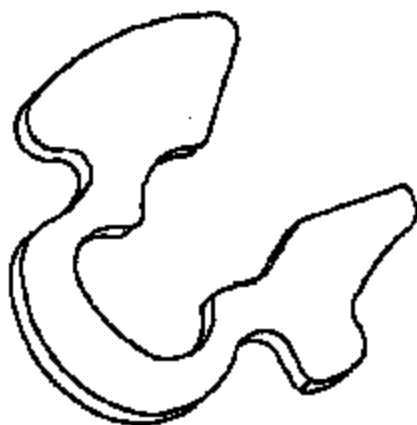
1633104

The illustration above shows the clip being removed in the next step and is for reference purposes only.

16. Once the threaded section of the lower cable has been pulled out, you should see the small metal clip (1) that attaches the inner cables (2) together. While holding the white cover back and using a pair of long-nose pliers (3), grasp and pull off the small metal clip through the opening in the cable connector and discard the clip.
17. Separate the upper cable from the lower cable and remove the upper cable from the vehicle.
18. From under the vehicle, push the new cable up through the opening in the floor.
19. Slide the cover back and pry the lock up the same way as was done on the original cable a few steps earlier.
