**GM SERVICE AND PARTS OPERATIONS
DCS1249
URGENT DISTRIBUTE IMMEDIATELY**

Subject: 04061A / Revised Product Safety Recall
Transmission Shift Cable Separation

Models: 2004 Chevrolet Express
2004 GMC Savana

Bulletin No.: 04061A

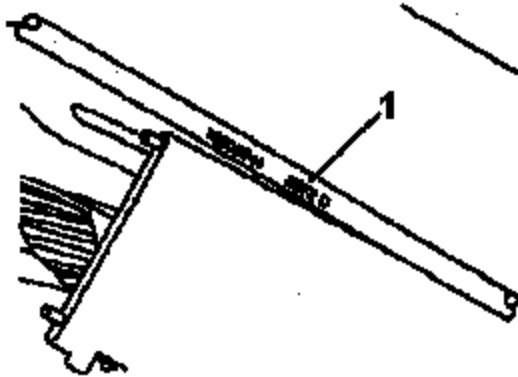
1530804

3. Pull the driver's side carpet down and rearward to expose the floor pan, transmission, and shift cable (1).

4. Locate the date code (1) printed on the shift cable as shown. The code follows a part number also printed on the cable.
 - o If the cable has a date code that is 4129 through 4139, the cable **MUST** be replaced. Proceed to the section title, "Shift Cable Replacement."
 - o If the cable has a date code before 4129 or after 4139, the cable does **NOT** need to be replaced and no further action is required. Reinstall the carpet and hinge pillar trim panel.

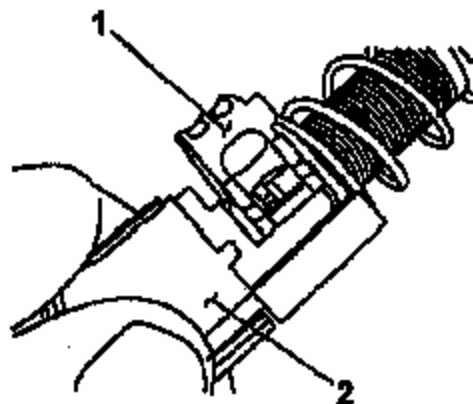
1533101

12. Pull (slide) the white cover (2) on the shift cable back to expose the natural colored lock (1)

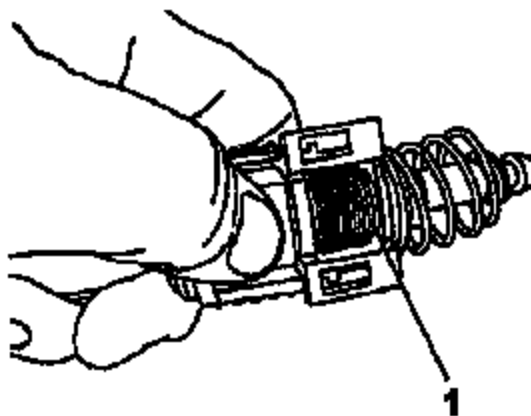
1633100

13. While holding the white cover (2) back, place a small flat-bladed screwdriver under the lock ramp located at the top of the lock (1) and pry the lock up.

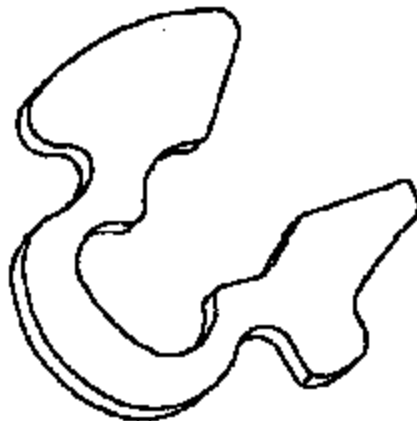
1633104

The illustration above shows the clip being removed in the next step and is for reference purposes only.

16. Once the threaded section of the lower cable has been pulled out, you should see the small metal clip (1) that attaches the inner cables (2) together. While holding the white cover back and using a pair of long-nose pliers (3), grasp and pull off the small metal clip through the opening in the cable connector and discard the clip.
17. Separate the upper cable from the lower cable and remove the upper cable from the vehicle.
18. From under the vehicle, push the new cable up through the opening in the floor.
19. Slide the cover back and pry the lock up the same way as was done on the original cable a few steps earlier.
