RECALL CAMPAIGN BULLETIN

NTB04-100

VOLUNTARY RECALL CAMPAIGN SKYVIEW ROOF GLASS

APPLIED VEHICLE: 2004 Maxima (A34)

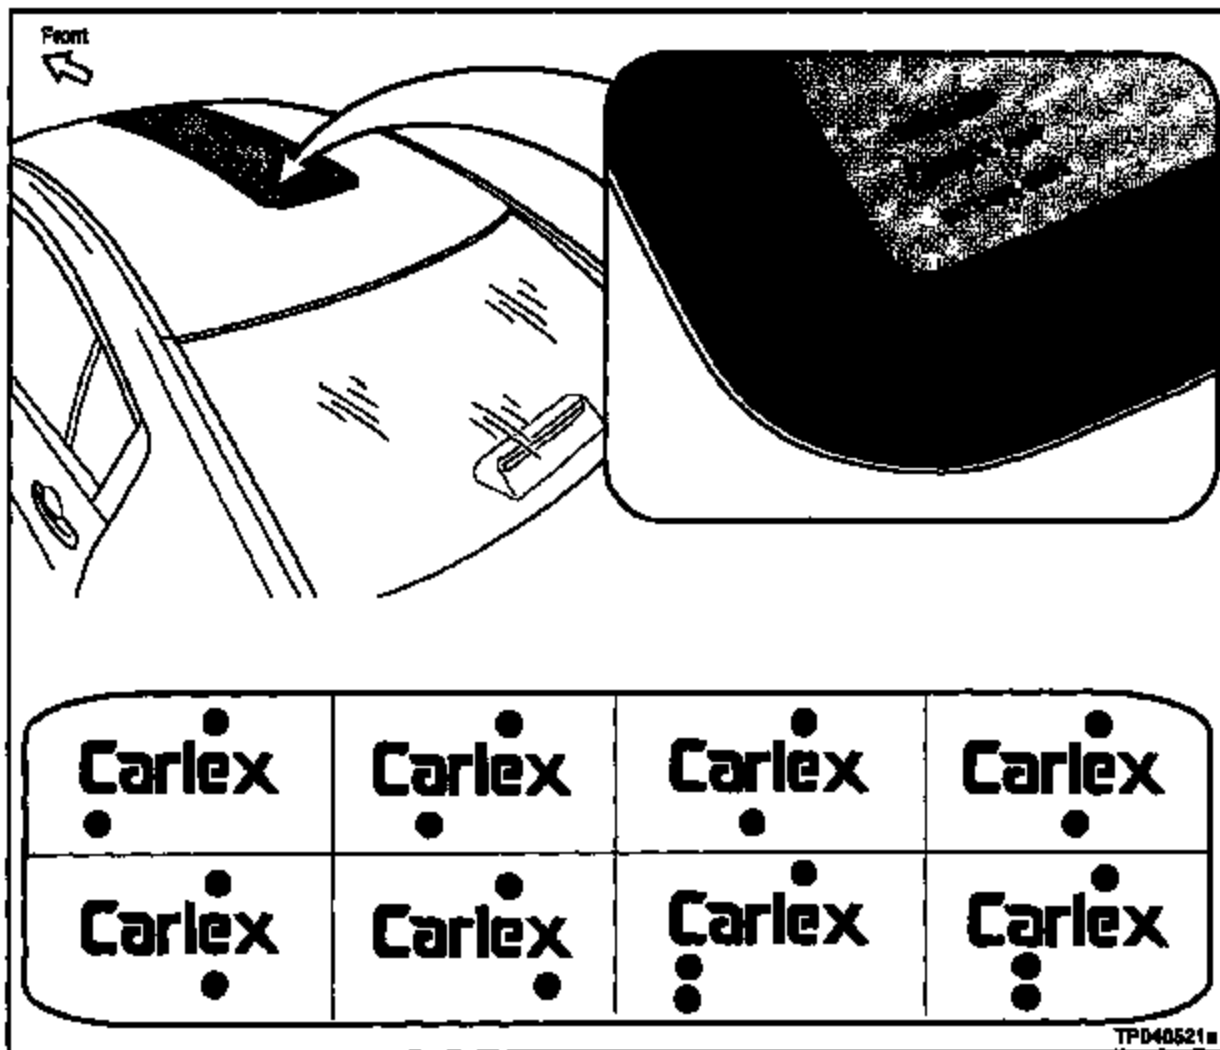
Figure 1

- Replace the Glass if the dots around the "CARLEX" name (located at the driver's side rear corner of the Glass) look like any one of the examples shown in Figure 1. In this case continue with step 2 of this procedure.

- Replace the Glass. Continue with step 2 of this procedure.
