Subject: Safety Recall 04V-327

Safety Recall 04S15:

Certain 2003 Model Year F-Super Duty and Excursion Vehicles Equipped With 6,0L

Negative Battery Terminal to Engine Block Connection

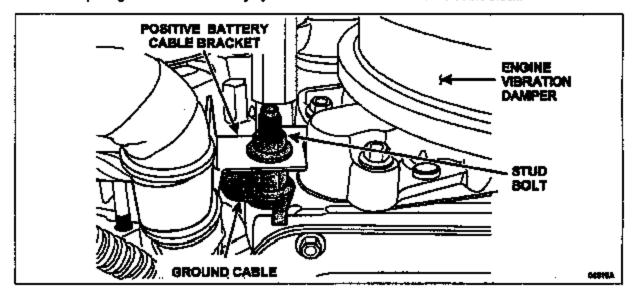
FIGURE 1

In some of the affected vehicles, it may be possible that the ground stud that retains the negative battery terminal eyelet to the engine block may be loose. A loose battery ground wire may produce high resistance to current flow. As a result, current may take an alternate path to ground through the radio suppression strap causing it to heat and potentially melt or ignite adjacent components.

- Raise and support the vehicle on a hoist.
- Locate the battery ground cable stud bolt at the right front comer of the engine block. See Figure 1.Grasp the ground cable assembly by hand and determine if it is locate at the block.

- Remove the positive battery cable bracket from the stud bolt.
- 4. Remove the ground cable stud bolt from the engine block and discard.
- Inspect for evidence of arcing or carbon buildup on the ground cable eyelet terminal.Clean as necessary.
- To ensure a good ground path, use a wire brush or equivalent to clean the engine block surface and ground cable mating surfaces.
- Install the new ground stud bolt. Tighten it to 62.5 Nm (48 lb-ft).
- Install the positive battery cable bracket to the stud bolt. Tighten it to 30 Nm (22 lb-ft).
- Grasp the ground cable assembly by hand and make sure it is tight at the engine connection.
- 10. Lower the hoist.

- Open the hood and locate the radio suppression strap near the right rear corner of the engine compartment.
- Inspect the suppression strap for signs of hest damage from increased amperage flow due to the loose ground connection at the engine block.
 - If no damage is found, close the hood and release the vehicle.
 - If the suppression strap shows signs of heat demage, inspect the surrounding components for similar demage. Repair as necessary.
