# DAIMLERCHRYSLER

July 2004

## **Safety Recall B21** **Rear Floorpan Reinforcement Spot Welds**

**2005 (LX) Chrysler 300 and Dodge Magnum**

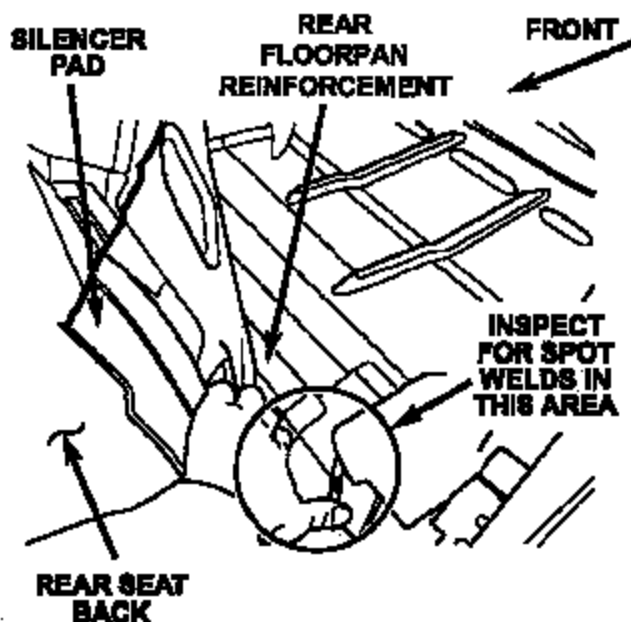
Figure 1

1. Open the trunk.
2. Lift the rear of the trunk floor cover and then pull the floor cover rearward.
3. Open the rear driver side door.
4. Fold the rear seat back forward to expose the cargo/trunk area.
5. Remove the seat back carpet push pin retainer on each side of the vehicle and then pull the carpet back.
6. Pull the floor silencer pad forward to expose the rear floorpan reinforcement (Figure 1).
7. Inspect the floorpan reinforcement for the presence of the two spot welds shown in Figure 2.
