# DAIMLERCHRYSLER

July 2004

## **Safety Recall B28** **Battery Cable Bulkhead Stud Fasteners**

2005 (LX) Chrysler 300 and Dodge Magnum

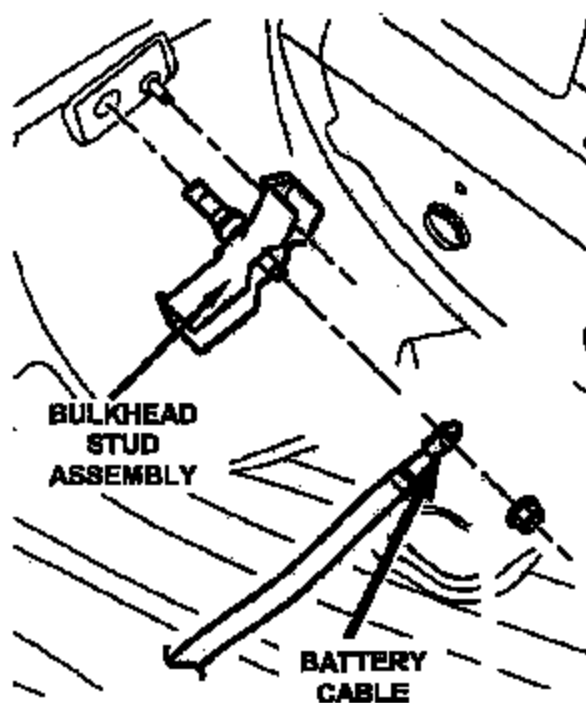
Figure 2

9. Inspect the battery cable bulkhead stud for signs of arcing and/or cross-threading (Figure 2). If the bulkhead stud is damaged, continue with **Section B – Replace Battery Cable Bulkhead Stud**.

10. Tighten the battery cable-to-bulkhead stud fastener to 80 in-lbs (9 N·m) (Figure 2).
11. Return the kick-up panel silencer pad to its original position.
12. Install the carpet and padding and install the carpet push pin.
13. Install the front door sill trim/kick panel (Figure 1).
14. Install the passenger side floor mat.
15. Close the front passenger door.
16. Raise the vehicle on an appropriate hoist.
17. Remove the six (6) passenger side underbody splash shield push pins (Figure 3).
18. Remove the underbody splash shield (Figure 3).
19. Inspect the battery cable bulkhead stud for signs of arcing and/or cross-threading (Figure 4). If the bulkhead stud is damaged, continue with **Section B – Replace Battery Cable Bulkhead Stud**.

6. Remove the retaining nut for the bulkhead stud assembly and then remove and discard the bulkhead stud assembly (Figure 2).
7. Install a new bulkhead stud assembly (P/N 05059113AC).

8. Install the bulkhead stud assembly retaining nut (Figure 2), tighten the nut to 80 in-lbs (9 N·m).
9. Install the battery cable onto the bulkhead stud (Figure 2). Install a new battery cable nut (P/N 06101809) and tighten to 80 in-lbs (9 N·m).
