July 2004

Safety Recall D30

Shoulder Belt Adjuster Turning Loop Bolts

2005 (LX) Chrysler 300 and Dodge Magnum

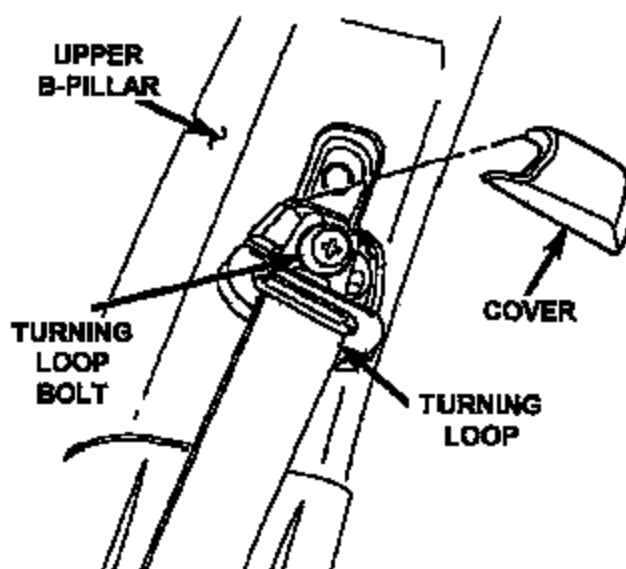
Figure 1 – Passenger Side Shown

The front shoulder belt adjuster turning loop bolts on about 12,000 of the above vehicles may not have been properly tightened. This could cause shoulder belt separation in certain crash conditions, which can increase the risk of injury to front seat occupants.

1. Using a trim stick placed between the turning loop cover and the release button, pry the top of the driver's side turning loop bolt cover open and then remove the cover (Figure 1).
2. Tighten the turning loop bolt to 30 ft-lbs (40 N·m).
3. Install the turning loop bolt cover by aligning catches on the bottom of the cover with the turning loop bracket and then snapping the cover over the top of the bracket. Ensure that the cover is fully installed.

NOTE: There should be no gap between the turning loop cover and the turning loop. Pinch the turning loop and cover with your finger and thumb to fully seat the cover.

NOTE: If the turning loop cover was damaged during removal, replace it with a new cover (P/N 5HF07BD1AC).
