Reference: NHTSA Identification Number 04V-337

Safety Recall D33 – Valve Cover Studs

2004 (KJ) Jeep® Liberty

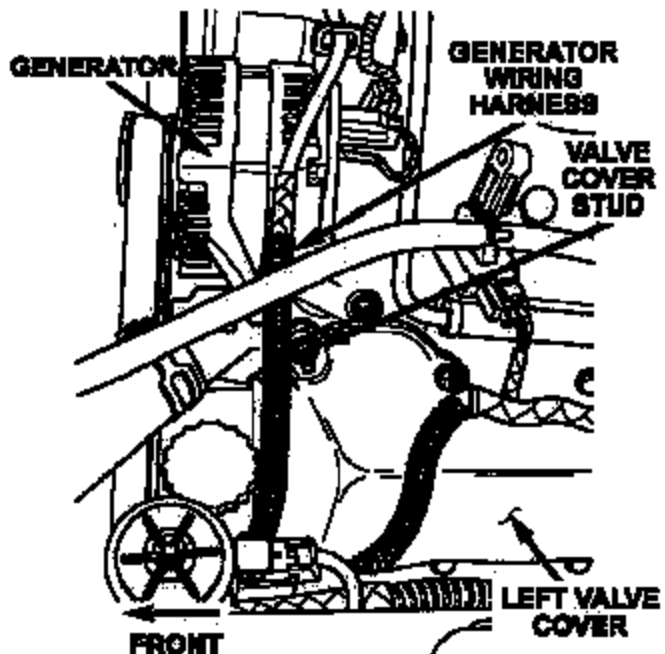
Figure 1

The generator and fuel injector wiring harnesses on about 1,500 of the above vehicles may short circuit due to contact with two valve cover studs. A short circuit in the generator harness can cause an underhood fire. A short circuit in the injector harness can cause the engine to stall and result in a crash without warning.

1. Open the hood.
2. Inspect the generator wiring harness where it passes the valve cover stud located on the front left corner of the engine (Figure 1). If the wiring insulation is damaged from contact with the stud, wrap it with high quality electrical tape.
3. Install one of the protective caps over the stud on the left front corner of the valve cover (Figure 1).
