PRODUCT CAMPAIGN BULLETIN

APPLICABILITY: 2002~03MY Subaru Impreza
SUBJECT: Left Front Seat Slide Rail Bolt

NUMBER: WWT-04
DATE: 08/2004

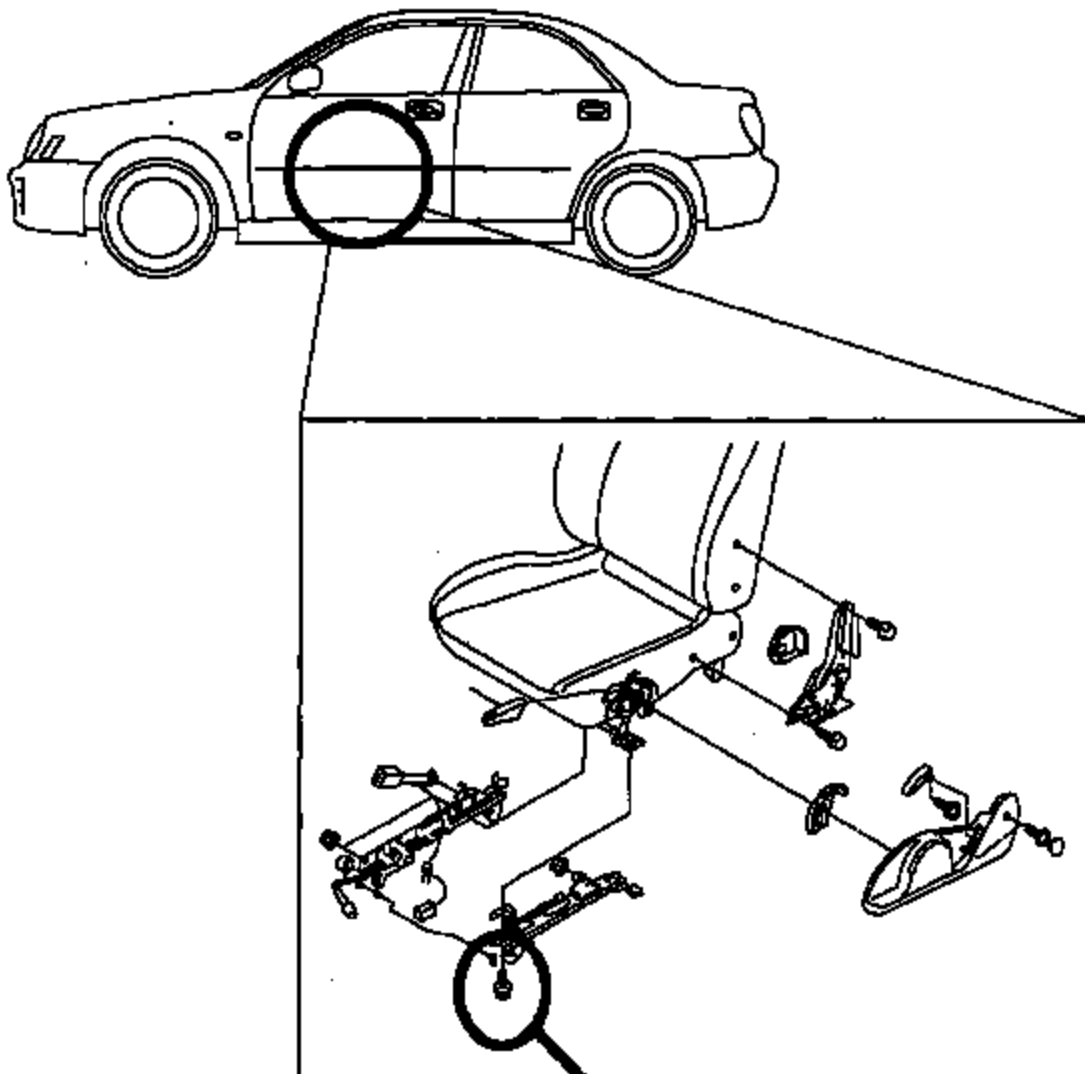
Subaru of America, Inc. (SOA) has determined that the left front bolt that retains the forward part of the driver's seat to the seat rail in certain 2002 - 2003 MY Impreza vehicles may loosen and possibly fall out due to stress caused by normal occupant movement. If the bolt were to loosen and fall out, there is the possibility that the seat may separate from the seat slide in a crash, which would pose a safety hazard to the driver.

- 1) Open the driver's door fully.
- 2) Locate the bolt as shown in the illustration below.
- 3) Gain access to the bolt by positioning the seat at the 5th notch from the front on the slide rail. Ratchet the height adjustment to the upward position.
- 4) Remove the original bolt and install the new slide rail 12mm retention bolt & washer assembly with thread-locking compound. Torque to 18 ft-lb. (24.5Nm)

Note: In case the new bolt is hard to position, loosen the four front seat mounting bolts. Install the new bolt and retorque the seat mounting bolts to 39 ft-lb (53Nm).

The original bolt should be replaced with a new bolt and washer assembly.
