TOYOTA CUSTOMER SERVICES

Volume: XI
Number: TGD-011
Date: 7/28/2004
 Action
 Retain
 Information

SUBJECT: SPECIAL SERVICE CAMPAIGN (SSC) – 40F
(2002 TO EARLY 2004 MODEL YEAR NORTH AMERICAN PRODUCED TOYOTA
CAMRY CURTAIN SIDE AIRBAG)

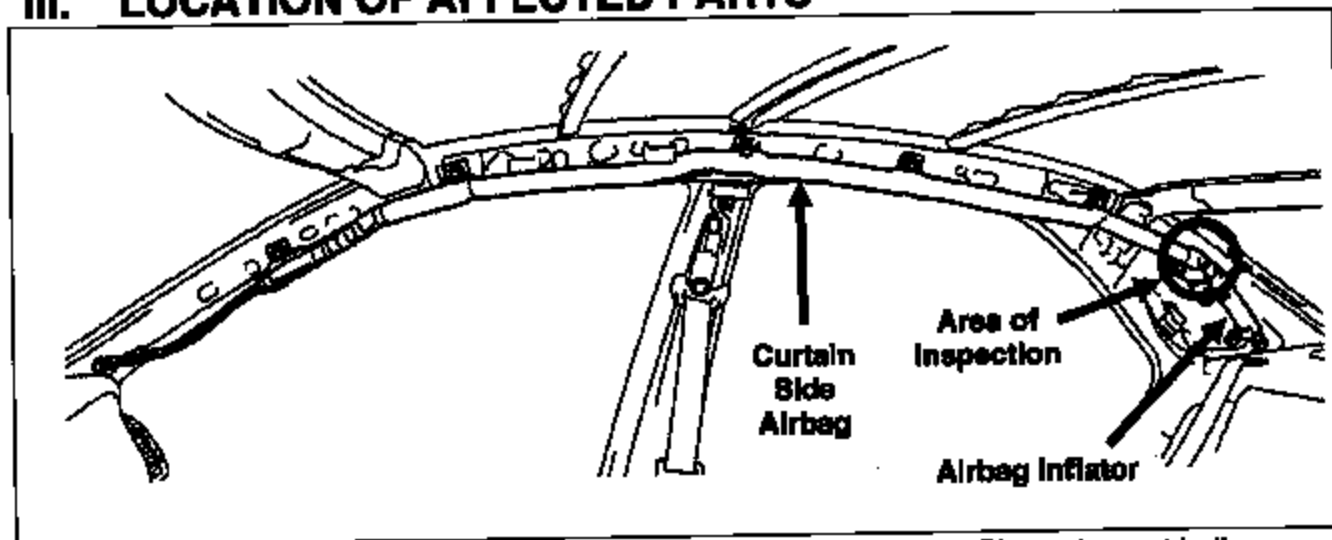
III. LOCATION OF AFFECTED PARTS

- Both LH and RH Curtain Side Airbags are affected by this campaign. Please inspect both sides.

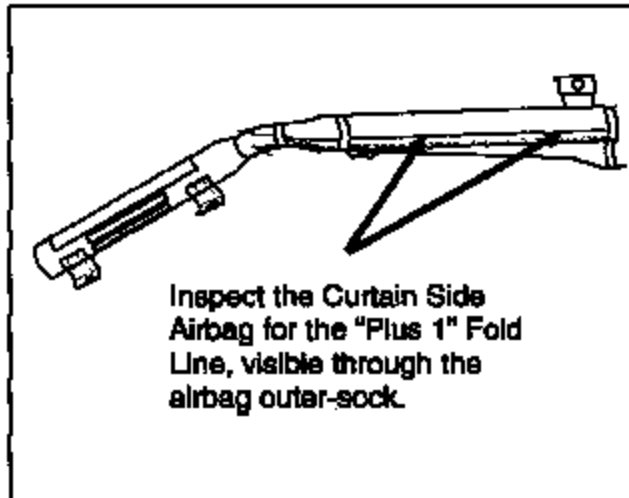
Inspect the Curtain Side Airbag for the "Plus 1" Fold Line, visible through the airbag outer-sock.

It will now be necessary to inspect the Curtain Side Airbag for the "Plus 1" Fold Line. The "Plus 1" Fold Line is part of the Curtain Side Airbag material, and is under the airbag outer-sock. The "Plus 1" Fold Line will be visible through the airbag outer-sock and should be approximately parallel with the airbag outer-sock stitching. The Fold Line on an OK part will be within ± 10 mm of the airbag outer-sock stitching along the entire length of the Curtain Side Airbag. Please carefully follow the inspection instructions on the next page to accurately determine the condition of the Curtain Side Airbag.

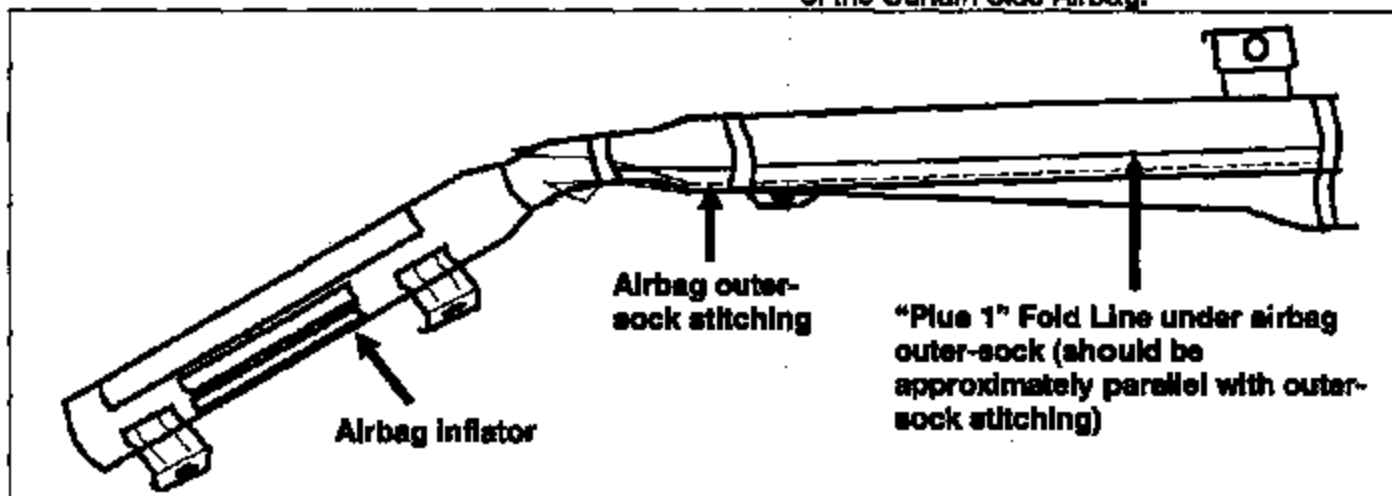
<p>Check Range "Plus 1" Fold Line OK</p>	<p>Check Range "Plus 1" Fold Line NG</p>	<p>Check Range "Plus 1" Fold Line NG</p>
<p>OK – "Plus 1" Fold Line parallel with outer-sock stitching.</p> <p>1. If the "Plus 1" Fold Line is parallel with the airbag outer-sock stitching (within a band of ± 10 mm (3/8 inch)), as illustrated above, the part is OK. Proceed to "Section VII, D." to reassemble the vehicle.</p>	<p>NG – "Plus 1" Fold Line NOT parallel with outer-sock stitching.</p> <p>2. If the "Plus 1" Fold Line is not parallel with the airbag outer-sock stitching (within a band of ± 10 mm (3/8 inch)), as illustrated above, the part is NG. Proceed to "Section VII." to replace the Curtain Side Airbag.</p>	<p>NG – "Plus 1" Fold Line NOT parallel with outer-sock stitching.</p> <p>3. If the "Plus 1" Fold Line is not parallel with the airbag outer-sock stitching (within a band of ± 10 mm (3/8 inch)), as illustrated above, the part is NG. Proceed to "Section VII." to replace the Curtain Side Airbag.</p>

<p>Approximately 98% of affected vehicles will have this condition.</p> <p>To view a sample click on the following link: [TIS OK Video 2 Here]</p>	<p>Approximately 1% of affected vehicles will have one of these conditions.</p> <p>To view a sample click on the following link: [TIS NG Video 2 Here]</p>
