# TOYOTA CUSTOMER SERVICES

Volume: XI  
Number: TC04-011  
Date: 7/26/2004  
 Action  
 Retain  
 Information

SUBJECT: SPECIAL SERVICE CAMPAIGN (SSC) – 40F  
(2002 TO EARLY 2004 MODEL YEAR NORTH AMERICAN PRODUCED TOYOTA  
CAMRY CURTAIN SIDE AIRBAG)

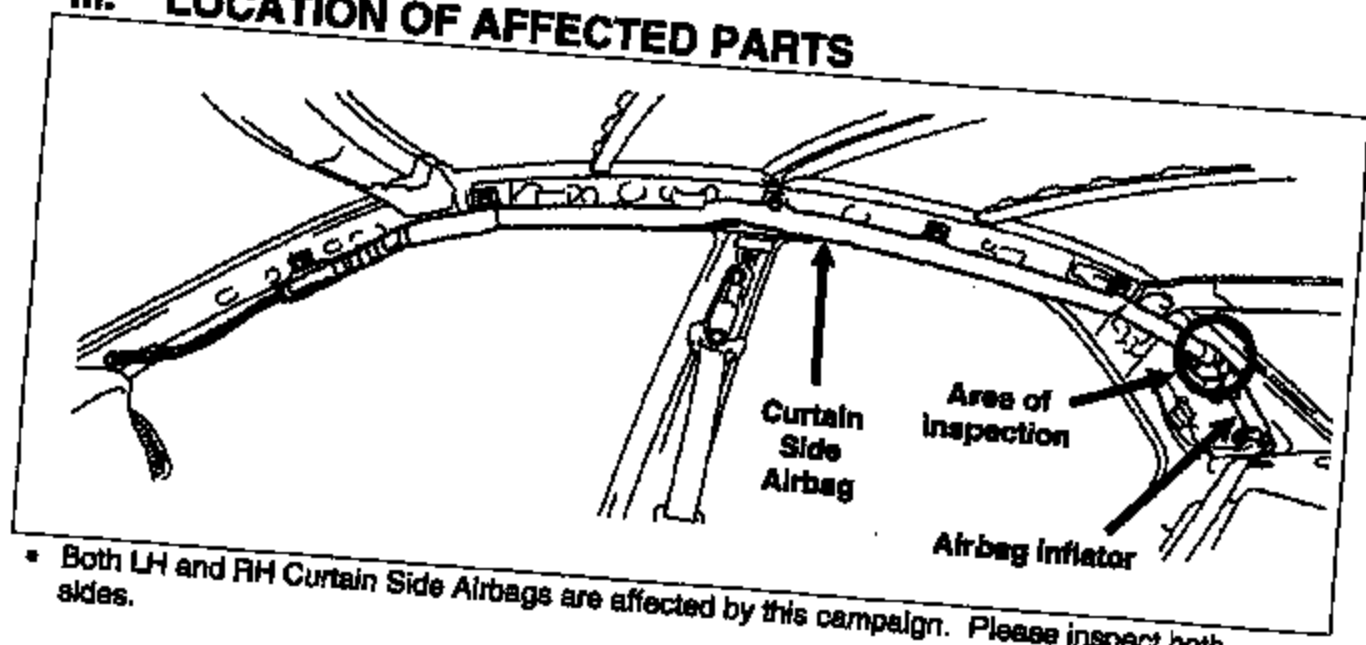
### III. LOCATION OF AFFECTED PARTS

- Both LH and RH Curtain Side Airbags are affected by this campaign. Please inspect both sides.

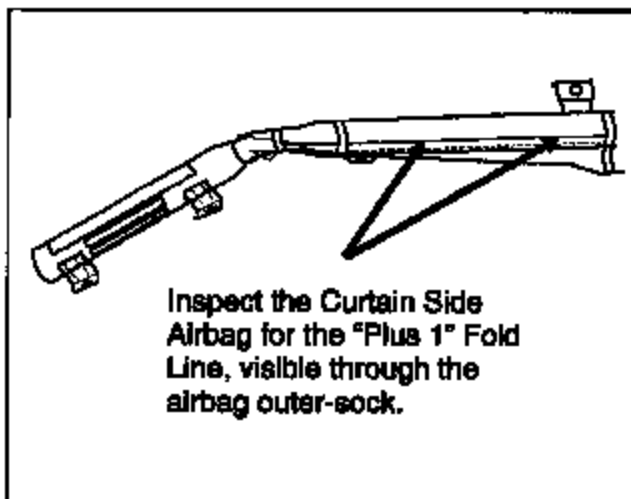
**1. INSPECT THE CURTAIN SIDE AIRBAG ASSEMBLY FOR THE "PLUS 1" FOLD LINE (Headliner Removed)**

It will now be necessary to inspect the Curtain Side Airbag for the "Plus 1" Fold Line. The "Plus 1" Fold Line is part of the Curtain Side Airbag material, and is under the airbag outer-sock. The "Plus 1" Fold Line will be visible through the airbag outer-sock and should be approximately parallel with the airbag outer-sock stitching. The Fold Line on an OK part will be within  $\pm 10$  mm of the airbag outer-sock stitching along the entire length of the Curtain Side Airbag. Please carefully follow the Inspection Instructions on the next page to accurately determine the condition of the Curtain Side Airbag.

- (a) Inspect the Curtain Side Airbag for the "Plus 1" Fold Line. The "Plus 1" Fold Line will be visible through the airbag outer-sock. The Fold Line can also be felt by lightly sliding a hand across the airbag outer-sock.
- (b) Use the table below to determine the condition of the Curtain Side Airbag.

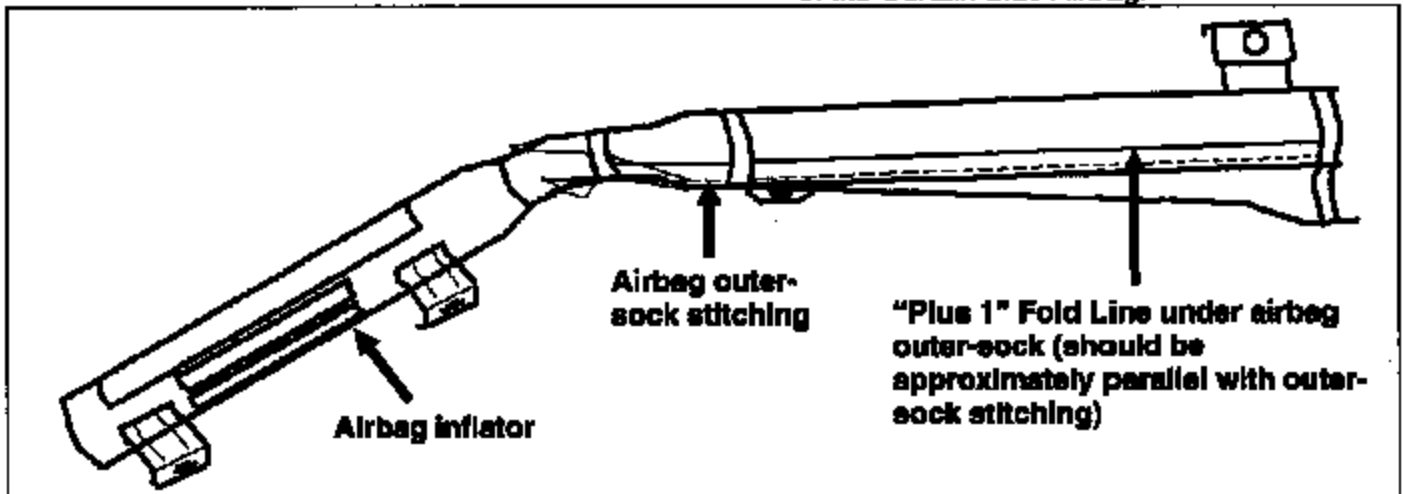
<p>Check Range "Plus 1" Fold Line <b>OK</b></p>	<p>Check Range "Plus 1" Fold Line <b>NG</b></p>	<p>Check Range "Plus 1" Fold Line <b>NG</b></p>
<p><b>OK – "Plus 1" Fold Line parallel with outer-sock stitching.</b></p>	<p><b>NG – "Plus 1" Fold Line NOT parallel with outer-sock stitching.</b></p>	<p><b>NG – "Plus 1" Fold Line NOT parallel with outer-sock stitching.</b></p>
<p>1. If the "Plus 1" Fold Line is parallel with the airbag outer-sock stitching (within a band of <math>\pm 10</math> mm (3/8 inch)), as illustrated above, the part is OK. Proceed to "Section VII, D." to reassemble the vehicle.</p>	<p>2. If the "Plus 1" Fold Line is not parallel with the airbag outer-sock stitching (within a band of <math>\pm 10</math> mm (3/8 inch)), as illustrated above, the part is NG. Proceed to "Section VII." to replace the Curtain Side Airbag.</p>	<p>3. If the "Plus 1" Fold Line is not parallel with the airbag outer-sock stitching (within a band of <math>\pm 10</math> mm (3/8 inch)), as illustrated above, the part is NG. Proceed to "Section VII." to replace the Curtain Side Airbag.</p>

<p><b>Approximately 99% of affected vehicles will have this condition.</b></p>	<p><b>Approximately 1% of affected vehicles will have one of these conditions.</b></p>	
<p>To view a sample click on the following link <b>[TIS OK Video 2 Here]</b></p>	<p>To view a sample click on the following link: <b>[TIS NG Video 2 Here]</b></p>
