**G-04512-R1**  
**March 2005**

**SUBJECT: SAFETY RECALL (U.S., EXPORT)**  
**POWER STEERING HOSE ROUTING, ENGINE**  
**HARNESS ROUTING and OIL PRESSURE SWITCH**  
**on certain MODEL YEAR 2005 RE BUS models built**  
**3/3/2004 thru 8/5/2004 with I6 engines only.**

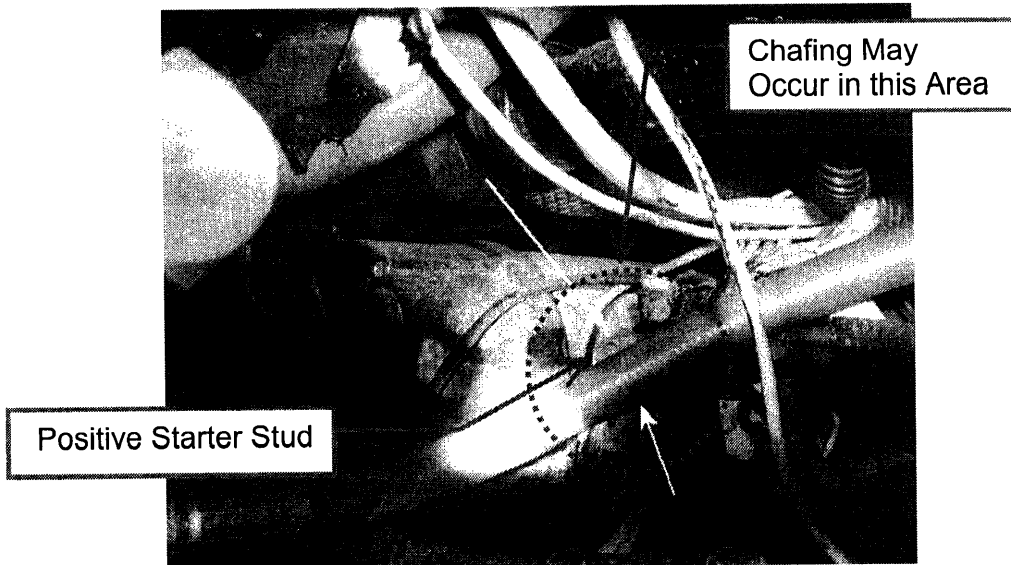
**Figure 1**

1. Inspect power steering hose for chafing damage in area near where it may have been in contact with the positive stud of the starter solenoid.

2. If any chafing has taken place, replace power steering hose, refill reservoir AND install conduit and strap-locks as indicated below.
3. Install conduit onto power steering hose. Ensure conduit runs from power steering pump to at least forward of bell housing, or clear of engine block.

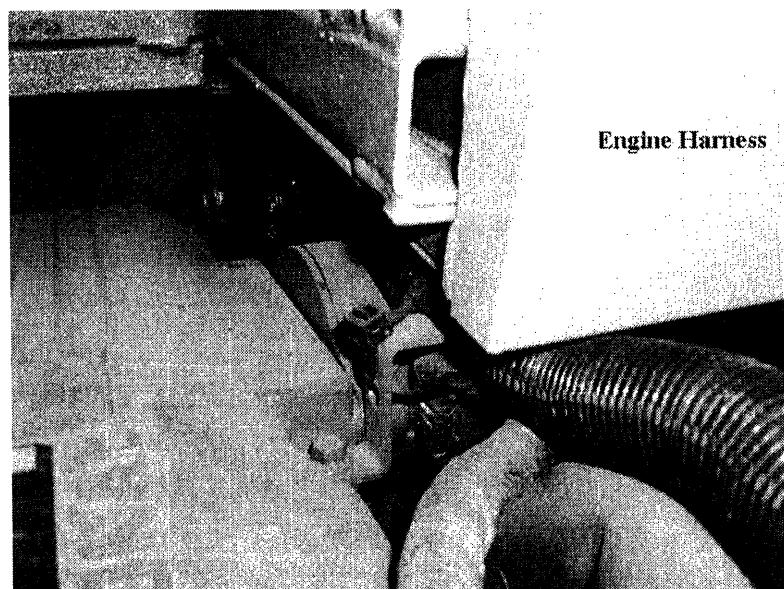
Figure 5

1. If the engine harness appears to be pinched on the right side at the rear of the engine air intake manifold and body, as in the figure below, re-route as indicated.
