**Re: Defect Information Report (FL-430), NHTSA no. 04V-401  
Condor Steering Gear Mounting Bolts**

**Section 573.6 Defect Information Report**  
**FL-430, NHTSA no. 04V-401**  
**Supplement No.: 1**

## Subject: Condor Steering Gear Mounting Bolts

March 2005  
FL430AB  
NHTSA #04V-401  
SECOND REVISED NOTICE

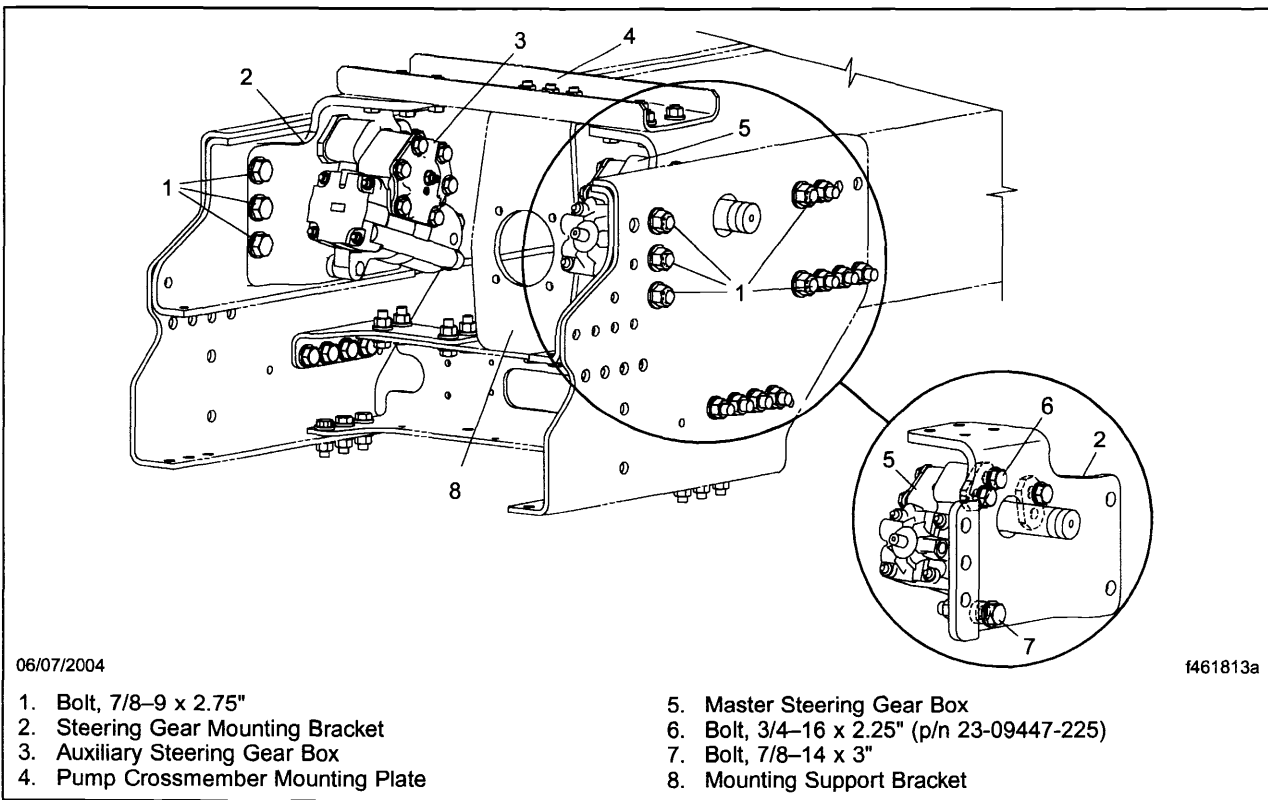
Fig. 1, Dual Steering Gear Mounting Bracket Assemblies (LH/RH Drive similar)

The bolts that attach the steering gear to the chassis mounting bracket may not have full thread engagement. The bolts may become loose and allow the steering gear to separate from the chassis which may lead to a loss of steering control, resulting in a possible vehicle crash without prior warning.

NOTE: The following procedures are the same for the left-hand-drive and right-hand-drive vehicles. On dual-gear vehicles, these procedures will apply to both gear boxes. Use replacement steering gear mounting bolts (p/n 23-09447-225 from kit 25-FL430-000); see Fig. 1, Ref. 6.

- 9.3 Using a two-jaw puller, remove the pitman arm from the input shaft. If the truck is equipped with SURHD (Stand-Up Right-Hand Drive), it may be necessary to use a chisel to spread the pitman arm so that it will slide off the sector shaft on the right-hand side of the vehicle.
10. Remove the pump crossmember mounting plate and mounting support bracket. See **Fig. 1**.
11. Remove the charge air cooler, and move the condenser aside.
