**Recall Campaign 04V- 402: Checking/Refitting the Suction Jet Pump.**

E53 X5 with the 3.0 liter M54 engine, and the 4.4 or 4.8 liter N62 engine produced from 4/5/2004 through 4/24/2004

**Recall Campaign No. 04V-402, Suction Jet Pump**

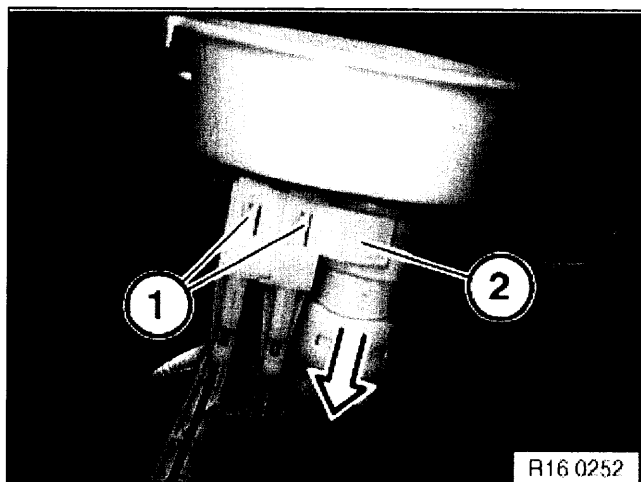
Carefully raise the level sensor until the connection (2) for the suction jet pump is accessible. Inspect the retaining lugs (1) and ensure that they are clearly and completely visible within their respective recesses. Refit if necessary.

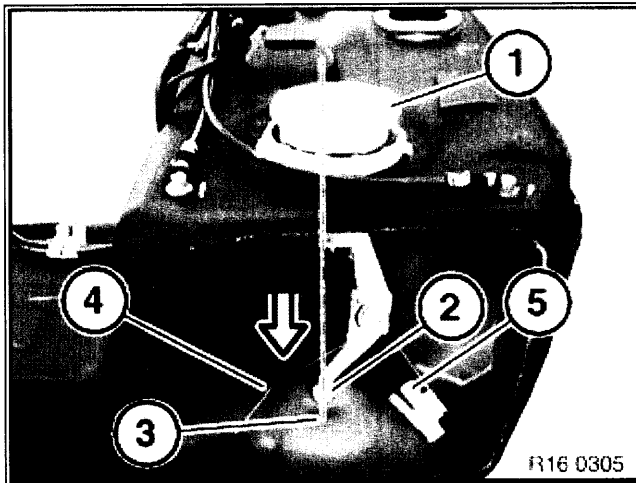
When reinstalling, ensure that the fuel level sensor is perfectly vertical so that the sensor foot (2) is positioned in the recess (3) at the bottom of the tank. Additionally, care should be taken so that the tubing (5) does not interfere with sensor arm (4)

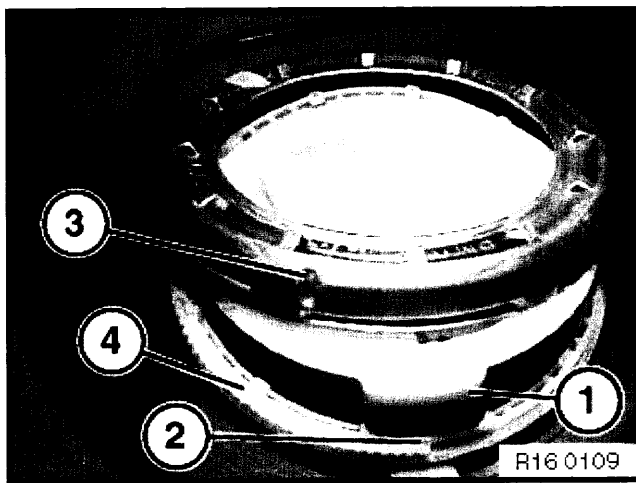
When reinstalling, replace the rubber gasket and ensure that the lug located on the level sensor (1) catches in the recess (2).

While retorquing the retaining ring, the engagement of the notch (3) with the toothed segment (4) will clearly be felt and heard. Tightening torque is 35 Nm. Reconnect the electrical connector and reinstall the hose using a new clamp.
