**RECALL CAMPAIGN BULLETIN**

NTB04-105

**VOLUNTARY RECALL CAMPAIGN  
A/T COLUMN SHIFTER****CAMPAIGN I.D. # / NHTSA #: RU403 / 04V-408****APPLIED VEHICLE: 2004 Titan (A60)****APPLIED VIN: 1N6AA0\*\*\*4N604115 - 505574****1N6AA0\*\*\*4N527814 - 548997****NOTE: You MUST use Service Comm to confirm campaign eligibility.****INTRODUCTION**

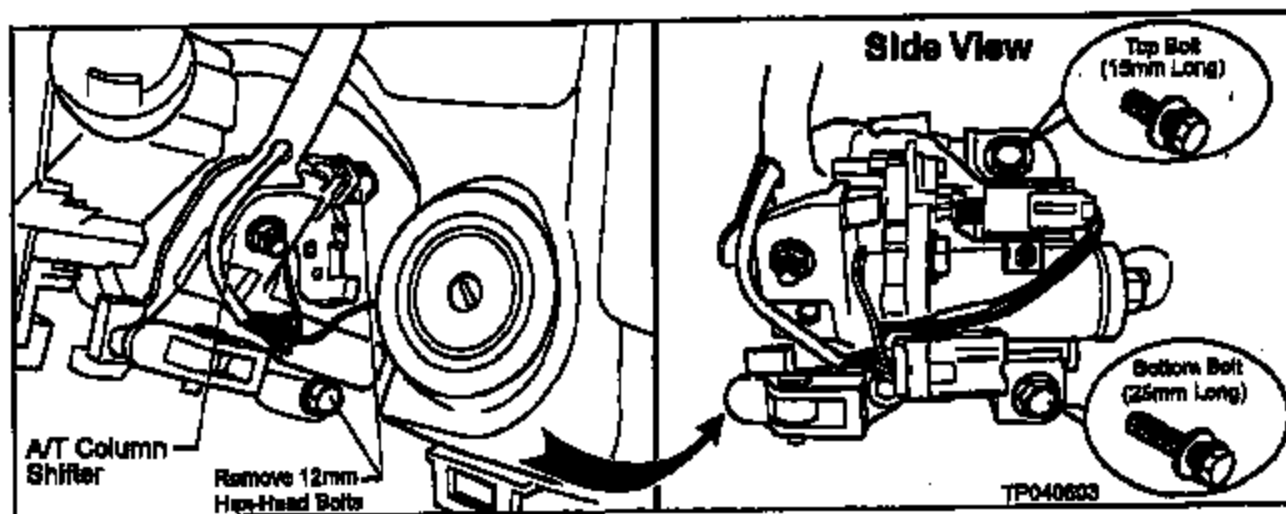
Nissan has determined that some 2004 model year Nissan Titan vehicles may have a defect which relates to motor vehicle safety. There is a possibility that the transmission shift lever assembly for the column shifter may have been damaged during manufacture. The damage could eventually result in the failure of the portion of the assembly that holds the shift lever in the "Park" position when the key is not in the ignition or when the key is in the "Lock", "Off" or "Accessory" position. This would allow the shift lever to be capable of being moved from "Park" without the key or when the ignition is in a position other than "On". In some situations, the ability of the shift lever to be moved out of the Park position could result in rollaway of the vehicle and cause a crash. To prevent this condition from occurring, Nissan is conducting a Voluntary Safety Recall Campaign to replace the shift lever assembly.

12. Remove the two 12mm Hex-Head Bolts and remove the original (old) A/T Column Shifter (see Figure 8).

- The top Bolt is 15mm long and the bottom Bolt is 25mm long

12. Install the new A/T Column Shifter (see Figure 8).

- The top Bolt is 15mm long and the bottom Bolt is 25mm long
- Tighten the Bolts to: 15 N-m (1.5 Kg-m, 11 ft-lb, 132 In-lb)
