Applies To: **2004 Odyssey** – From VIN 5FNRL1...4B069047 thru 5FNRL1...4B138658

September 30, 2004

### Safety Recall: Odyssey Fuel Pump Connector (Supersedes 04-049, dated August 26, 2004)

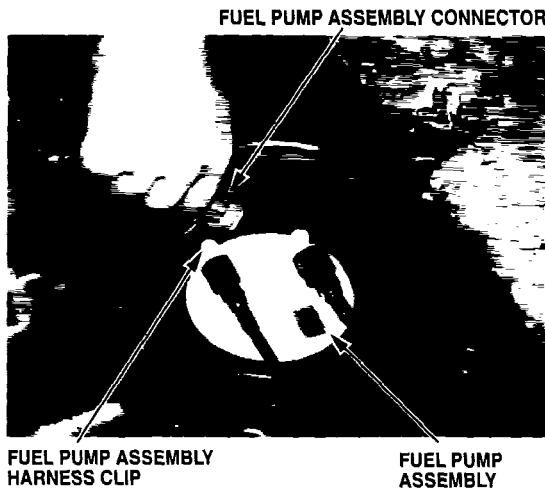
- Disconnect the fuel pump 5P connector from the top of the fuel tank unit, and detach the harness from the clip.
