**SAFETY
RECALL**

Sr04-13

DATE : SEPTEMBER 2004	SECTION : 16
SUBJECT : INSPECTION OF RADIUS ROD SUPPORT PINS

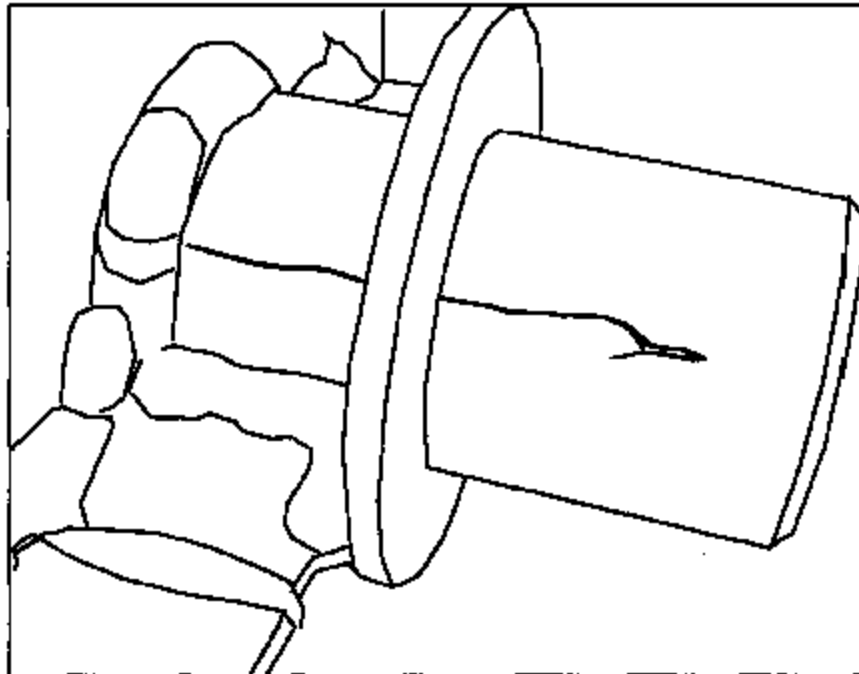
FIGURE 1: EXAMPLE OF CRACK

1. Dismount each radius rod by flattening the tabs of locking plate and by unscrewing the two bolts directly fastened into radius rod pivot (if needed, refer to maintenance manual). Thoroughly clean the parts contact surfaces by removing all trace of grease or rust preventive product.
2. Check support pin surface for cracks (Refer to example in figure 1).

3. If a defective support pin is detected, it must be replaced (Refer to figures 2, 3 and 4).
