**1998 – Early 2005 LX 470**  
**Daytime Running Lights (DRL)**

**Special Service Campaign 5LB**

**M/N 00241-10006-5LB**

**May 2005**

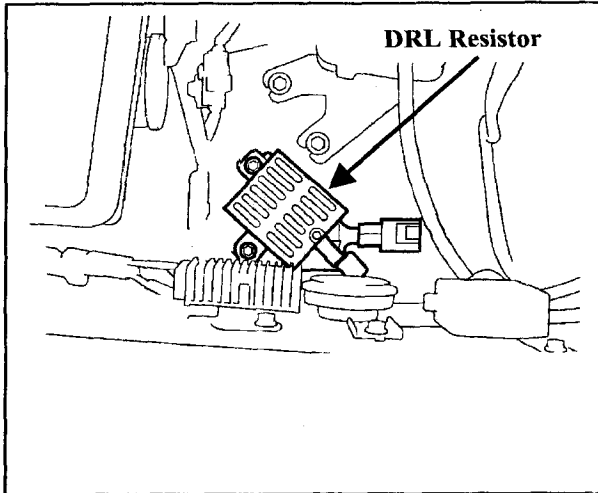
- (a) Inspect the vehicle to see if a DRL resistor is already installed. If already equipped, the resistor will be mounted on the right fender well between the air cleaner housing and the firewall.
