MITSUBISHI FUSO
TRUCK OF AMERICA, Inc.

Recall Information Bulletin

No: R3120420 **Issued:** 10/21/2004

Re: Cab Tilt Main Hook

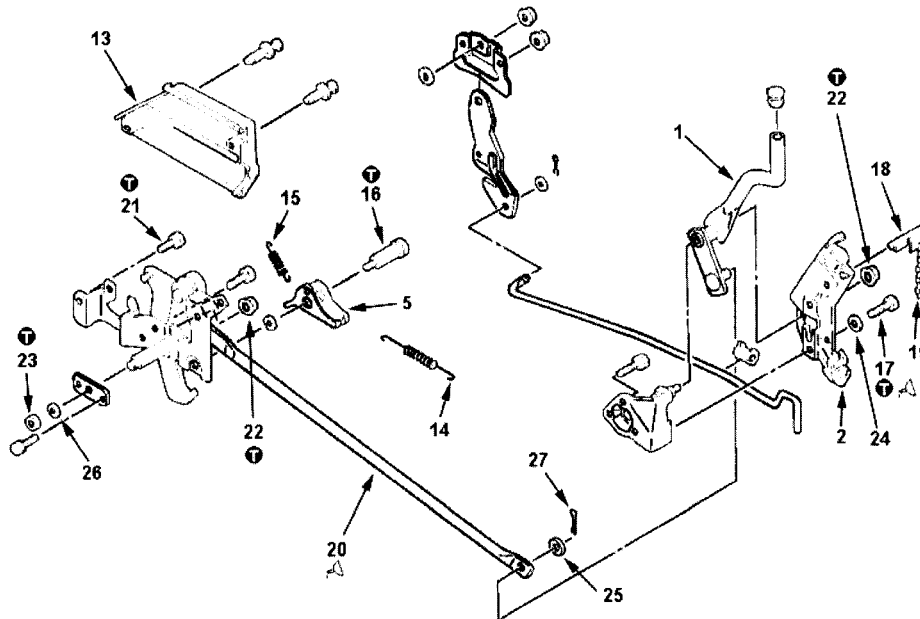
DIAGRAM 1

Mitsubishi Fuso Truck of America, Inc. has decided that a defect which relates to motor vehicle safety exists in the cab tilt main hook on certain vehicles. The cab tilt main hook is the latching mechanism that prevents the vehicle's cab from tilting forward during vehicle operation. On affected vehicles, the clearance between the main hook and surrounding components may be insufficient. Repeated normal cab tilting operation could cause the cab tilt system components to become damaged in the area of the cab main hook. If damage occurs, the cab main hook could latch improperly, and in the worst case, the cab could tilt forward during normal vehicle operation, which could result in a crash without warning.

- Remove the main hook cover 13.
- Remove return springs 14 & 15.
- Loosen the lock lever bolt 16 and remove the MC912231 lock lever 5.
- Remove the MC931140 main hook assembly 20.
- Remove the chain 19 and key 18 from the control lever bracket 2.
- Remove the MC907591 control lever bracket 2.

- Install the new Control Lever Bracket (MC964520) **2** loosely, applying adhesive to the Control Lever Bracket Mounting Bolt **17** threads, as described in the Adhesive and Lubricant table above.
- Install the new Main Hook Assembly (MC964511) **20**, tightening the Mounting Bolts **21** as specified in the Tightening Torque table. Apply grease to the sections described in the Adhesive & Lubricant table.
- Install Return Spring **15** on the Main Hook Assembly **20**.
- Installed the new Lock Lever (MC964516) **5**, tightening the Mounting Bolt **6** as specified in the Tightening Torque table.
- Install Return Spring **14** on the Lock Lever **5**.

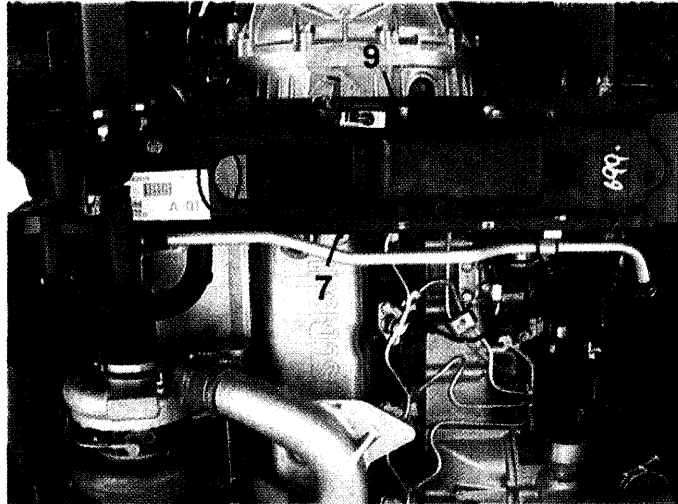
PHOTO 1

- Check for evidence of contact between the Main Hook Assembly 20 and the Hook Pin Bracket 7, Cab Bridge 8, and Hook Hinge Bracket 9. Contact in these areas is unacceptable.
- Contact in the area indicated within the red oval is considered acceptable.

If the Main Hook Assembly 20 contacts the Hook Pin Bracket 7 or Hook Hinge Bracket 9, repeat all disassembly and reassembly procedures.

- Loosen the Bolts 28 and Nuts 29.
- Push the Cab Bridge 8 forward until the Main Hook Assembly 20 properly clears the Cab Bridge 8 without contact.
- Retighten Bolts 28 and Nuts 29 as specified in the Tightening Torque table
