Frank M. Ligon
Director
Service Engineering Operations
Ford Customer Service Division

February 2005

SUBJECT: **Safety Recall 04S20: Supplement #5**
All 2002 and Certain 2003 Model Year Ford 4-Door Explorer & Mercury Mountaineer Vehicles - Liftgate Glass Hinge and Ball Stud Bracket (if applicable) Replacement

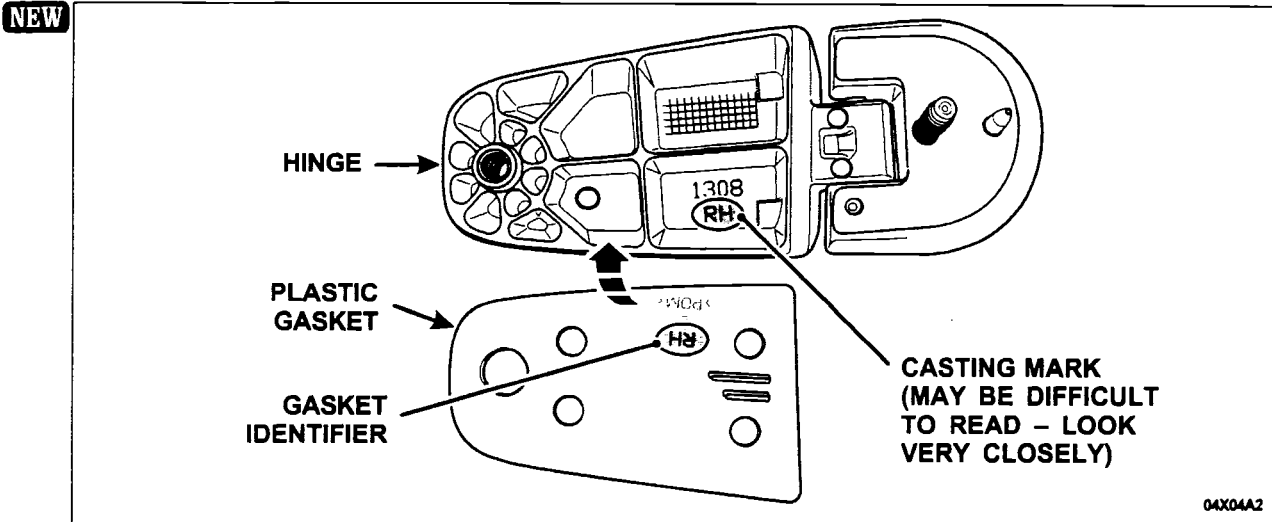
WARNING: THE *NEW* HINGES AND PLASTIC HINGE GASKETS ARE IDENTIFIED AS EITHER RIGHT-HAND OR LEFT-HAND (PASSENGER SIDE OR DRIVER SIDE). IF INSTALLED ON THE WRONG SIDE OF THE VEHICLE, THE GLASS MAY SHATTER. SEE FIGURE 1 FOR IDENTIFICATION DETAILS.

NOTE: On some hinges the casting marks are very light and difficult to read. Look closely to make sure each bracket is properly identified.

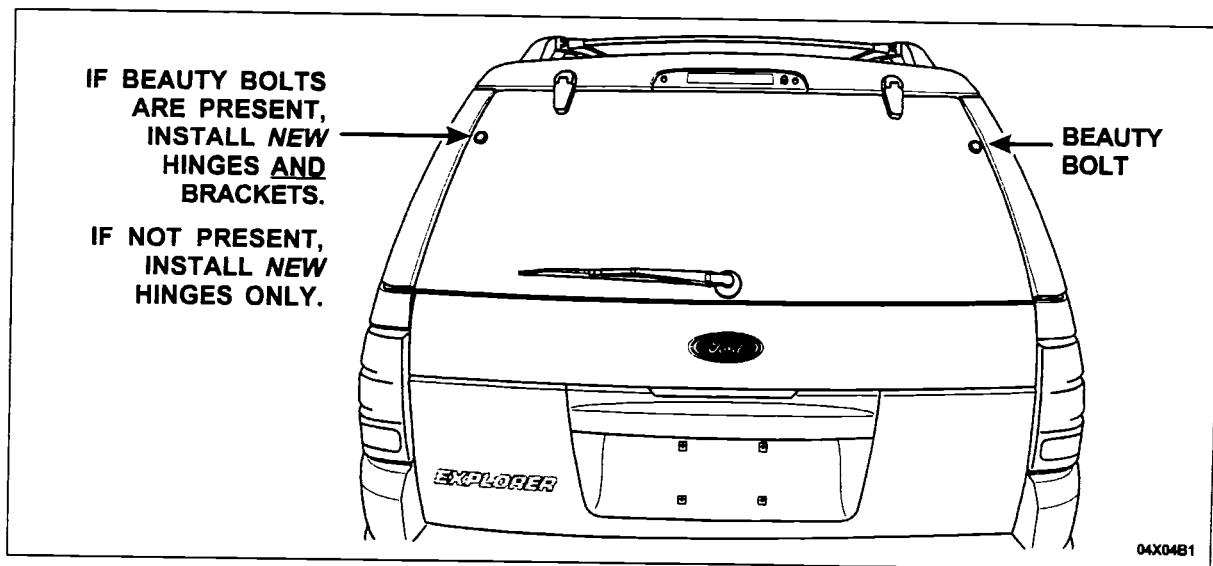
FIGURE 2

To properly identify the vehicle and decide which repairs to perform, inspect for the presence of liftgate glass beauty bolts.

- Early 2002 models use ball stud brackets that are secured with beauty bolts, which pass through the glass (the head of the bolt is visible on the outside of the glass) and are bonded to the glass about 150 mm (6 inches) from the top of the glass. See Figure 2. If beauty bolts are present, both the liftgate ball stud brackets and hinges will be replaced. Perform BOTH the Liftgate Glass Hinge Replacement and the Ball Stud Bracket Replacement. Begin your repairs with LIFTGATE GLASS HINGE REPLACEMENT.
- Later built 2002 and 2003 model year vehicles use revised ball stud brackets which are not secured with beauty bolts. If beauty bolts are not present, only the hinges will be replaced. Perform only the LIFTGATE GLASS HINGE REPLACEMENT.

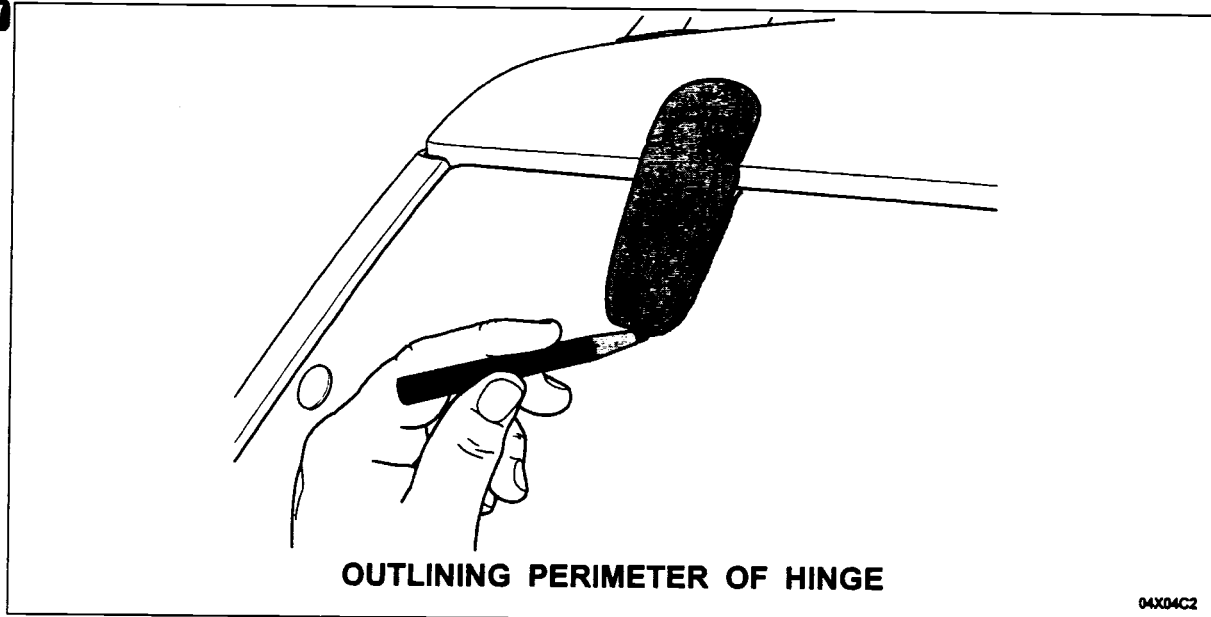
FIGURE 3

4. **CAUTION: The location of the original glass hinges must be clearly marked on the glass to make sure the *new* hinges are accurately positioned and that the glass is properly aligned. Failure to properly align the *new* hinges to these marks may result in glass shattering.**

Using a grease pencil, a non-permanent marker or tape, outline the entire perimeter of the original hinges to mark their exact location on the glass. See Figure 3.

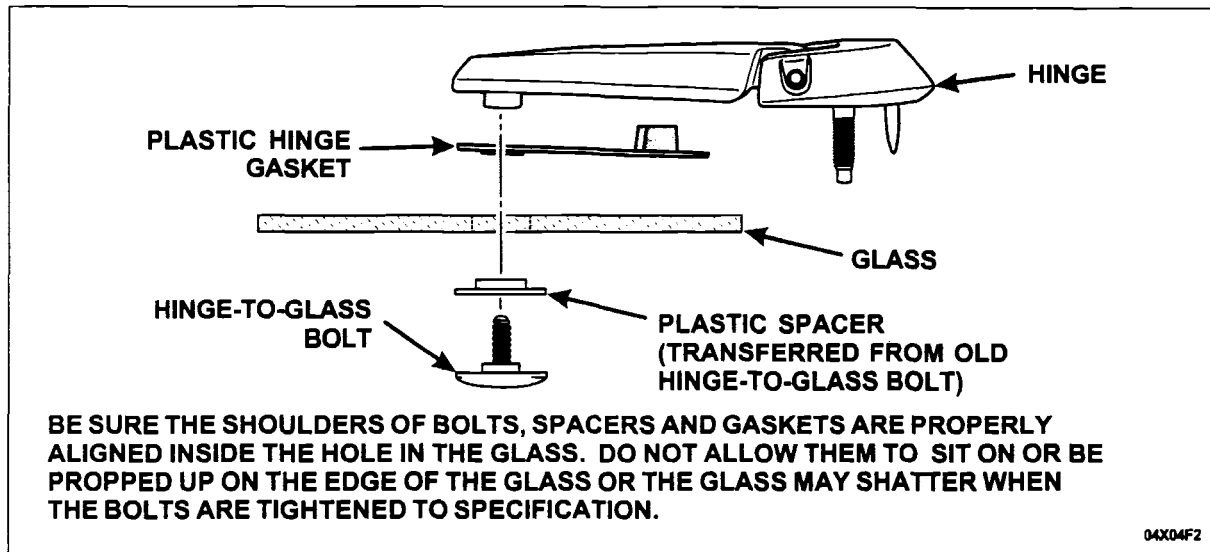
FIGURE 6

- The round plastic spacer under the hinge-to-glass bolt must be transferred to the new bolt. Failure to reuse the round spacer may result in the glass shattering upon bolt installation. (See Attachment III, page 4 of 14)

WARNING: THE PLASTIC SPACER LOCATED UNDER THE ORIGINAL HINGE-TO-GLASS BOLT MUST BE TRANSFERRED TO THE *NEW* BOLT. FAILURE TO INSTALL THIS SPACER WILL RESULT IN SHATTERING THE GLASS UPON BOLT INSTALLATION. SEE FIGURE 6.

WARNING: THE PLASTIC SPACER LOCATED UNDER THE ORIGINAL HINGE-TO-GLASS BOLT MUST BE CLEANED AND TRANSFERRED TO THE *NEW* BOLT. FAILURE TO INSTALL THIS SPACER WILL RESULT IN SHATTERING THE GLASS UPON BOLT INSTALLATION. SEE FIGURE 6.

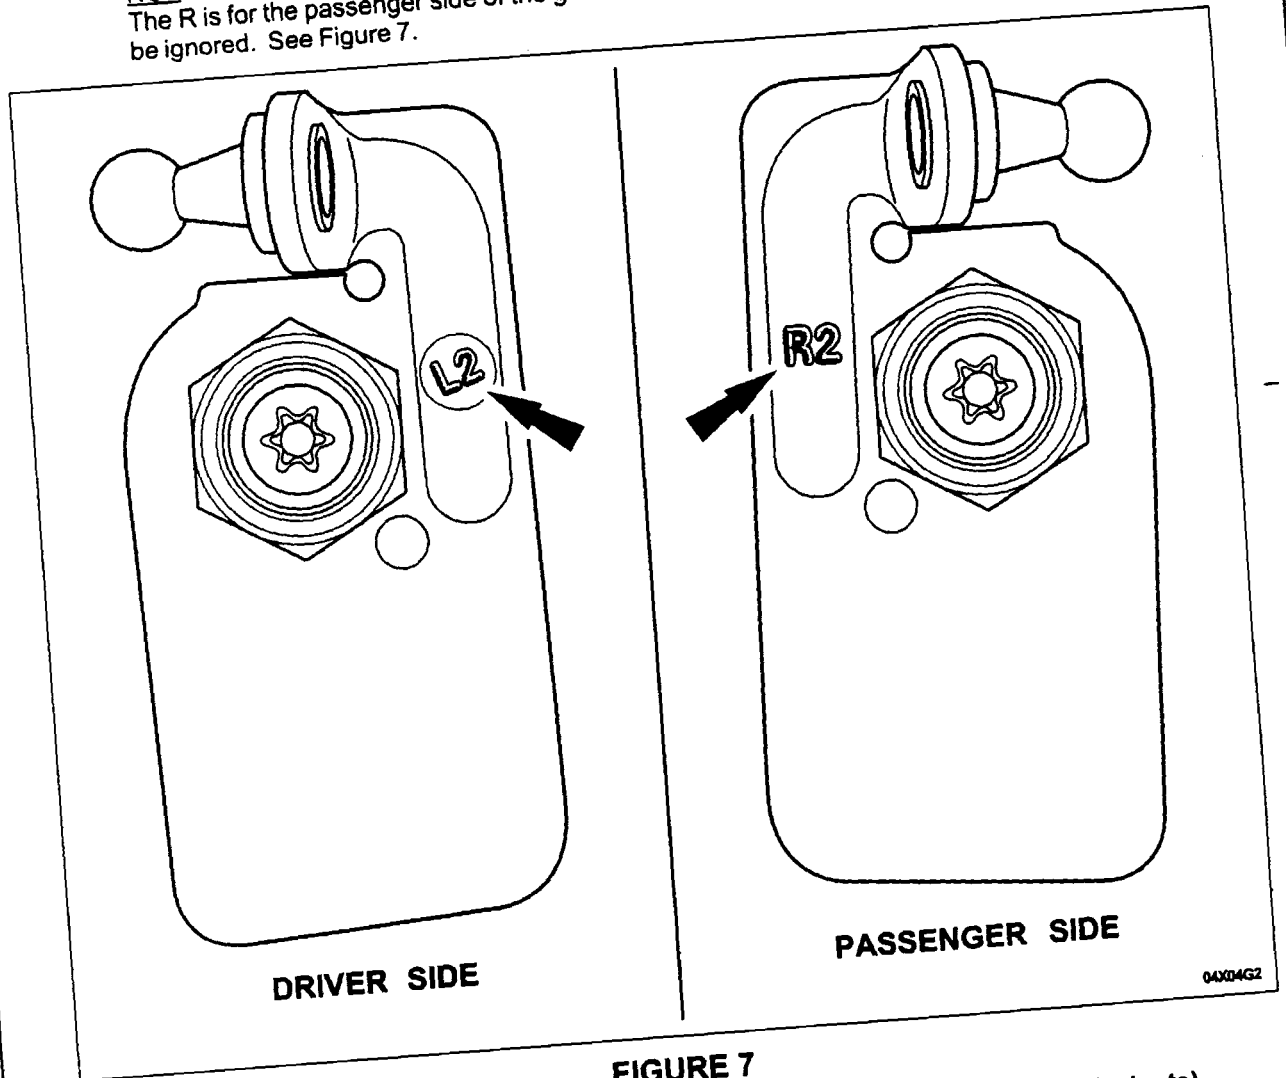
FIGURE 7

NOTE: The *new* brackets are marked with a stamping, L or R followed by a number. They are **NOT** interchangeable. The L is for the driver side of the glass and has left-hand threads. The R is for the passenger side of the glass and has right-hand threads. The number can be ignored. See Figure 7.

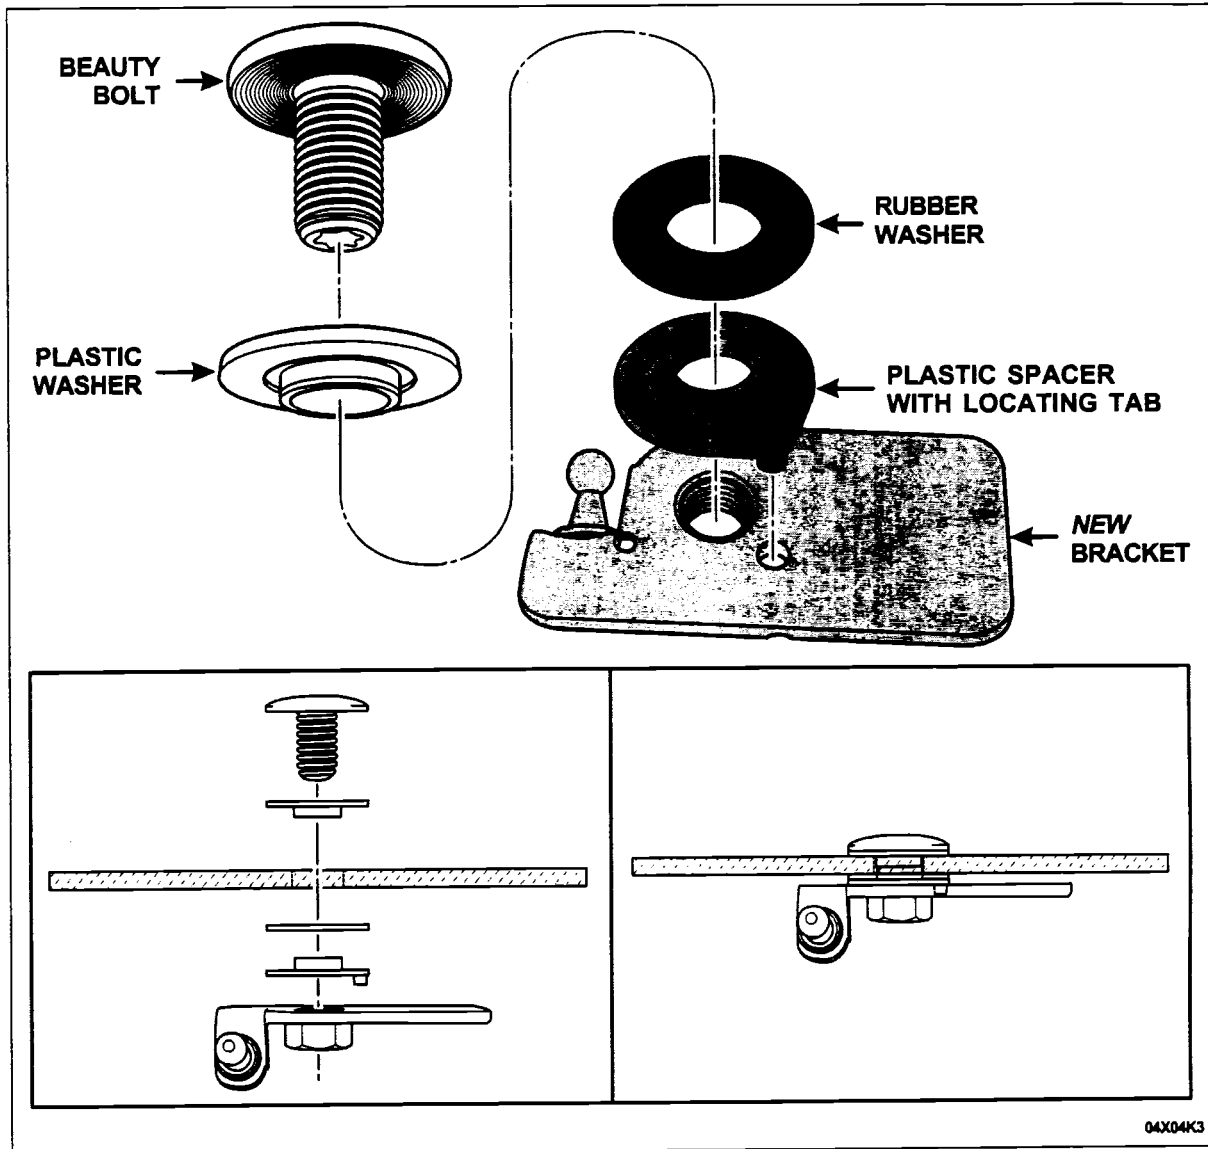
FIGURE 11

8. **CAUTION:** Be sure the glass and plastic washers are very clean and contain no grit, dirt, sand or any other foreign matter prior to installation. Even the smallest bit of any hard material captured between the plastic washer and the glass may cause the glass to shatter.

Install the plastic spacer (with locating tab) and rubber washer onto the *new* brackets as shown in Figure 11. Also, place a plastic washer onto the beauty bolt with the collar toward the glass.

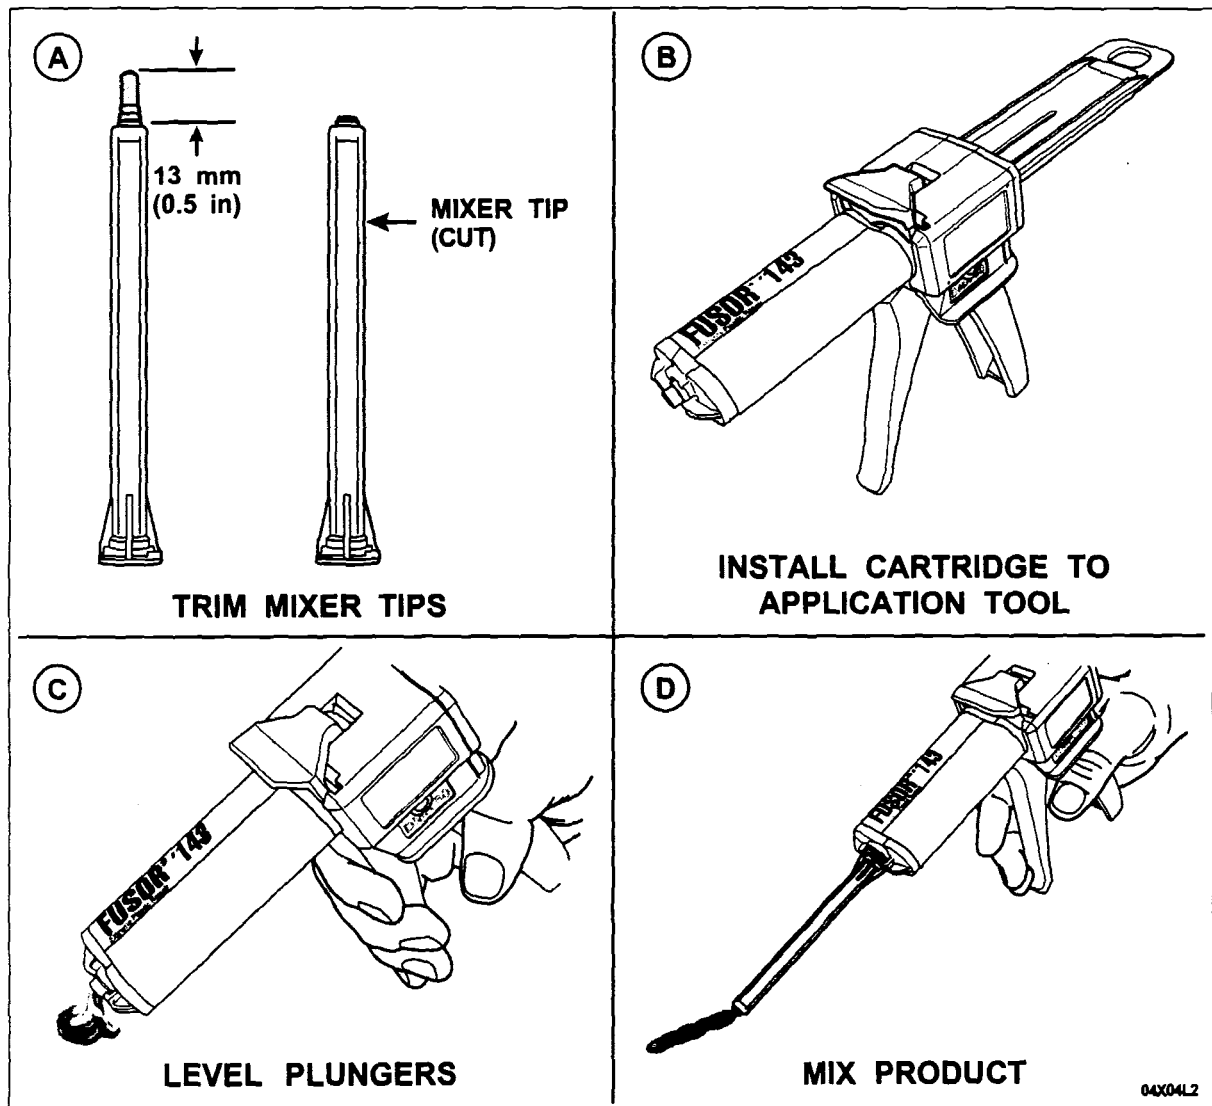
FIGURE 12

9. **CAUTION:** Failure to prepare the adhesive cartridge and mixer tip as described may cause insufficient mixing of the product. This may lead to insufficient bonding of the bracket(s) to the glass.

- A) Trim approximately 13 mm (0.5 in) off the top of both mixer tips, down to the last ring. See Figure 12.
- B) Install the Fusor® #143 adhesive cartridge into the application tool (No. 501-040).
- C) Dispense a small amount of adhesive from the cartridge onto a piece of scrap cardboard to level the plungers and to ensure an even flow of both components.
- D) Install one (1) mixer tip onto the cartridge and dispense a 75-mm (3-in) bead of the adhesive onto a piece of scrap cardboard (until the product is evenly mixed and the color is consistent).

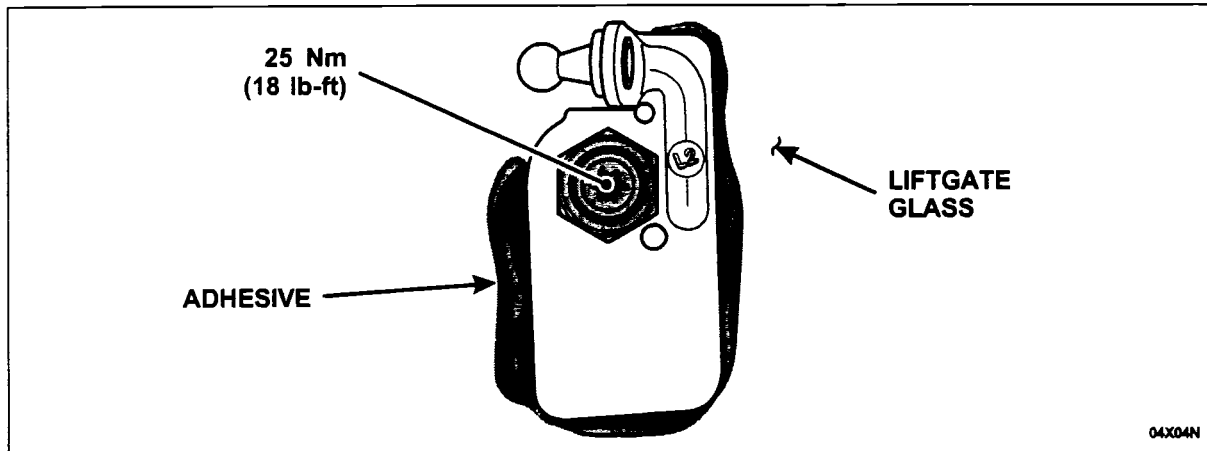
FIGURE 14

CAUTION: When working with glass, the torque specifications are very critical. Be sure the torque wrench used during this service has recently been calibrated so the fasteners are not over-tightened or under-tightened. Failure to use a calibrated torque wrench may result in glass shattering either during the repair or possibly after the repair is completed.

While holding the bracket nut with a 17-mm box or open-end wrench, tighten the bolt to 25 Nm (18 lb-ft). See Figure 14.

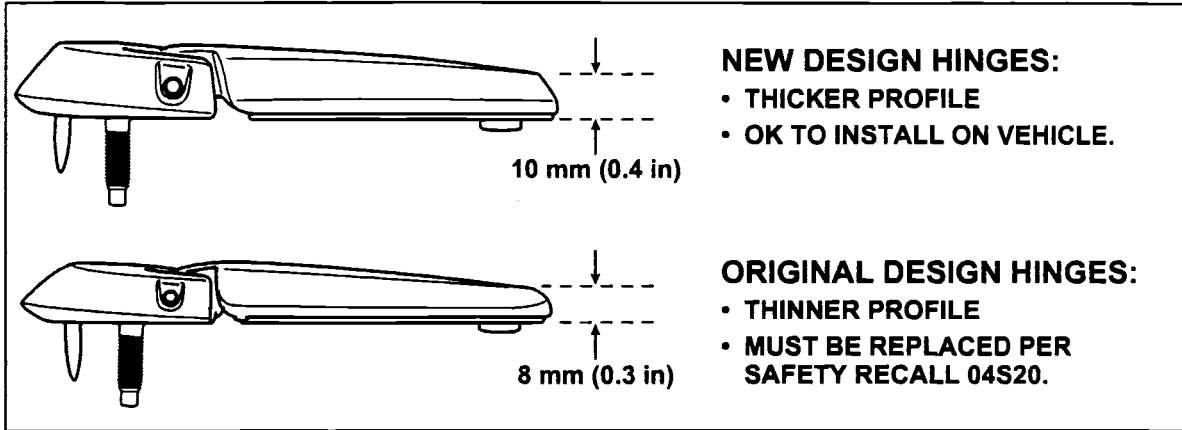
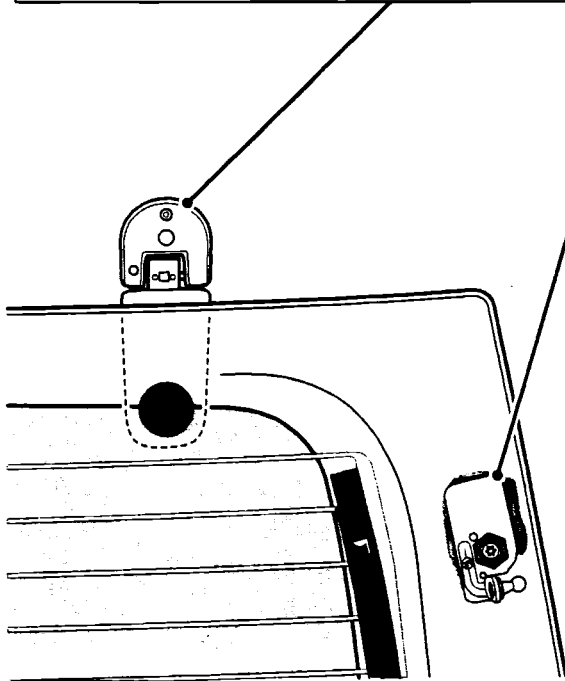
THE REPLACEMENT GLASS MUST HAVE:

- The new design hinges.
- Large strut brackets.
- Hard adhesive.

LARGE BRACKET:

- INSPECT FOR SOFT ADHESIVE BY ATTEMPTING TO LEAVE IMPRESSIONS WITH FINGERNAIL.
- BRACKET MUST BE REPLACED PER SAFETY RECALL 04S20 IF ADHESIVE IS SOFT.
- BRACKETS OK IF ADHESIVE IS HARD.
