Subject: Safety Recall 04V-442
(Ford Number 04S20)

SUBJECT: Advance Notice - Safety Recall 04S20:
All 2002 and Certain 2003 Model Year Ford Explorer & Mercury Mountaineer Vehicles
Liftgate Glass Hinge and Ball Stud Bracket (if applicable) Replacement

SUBJECT: Safety Recall 04S20

All 2002 and Certain 2003 Model Year Ford Explorer & Mercury Mountaineer Vehicles
Liftgate Glass Hinge and Ball Stud Bracket (if applicable) Replacement

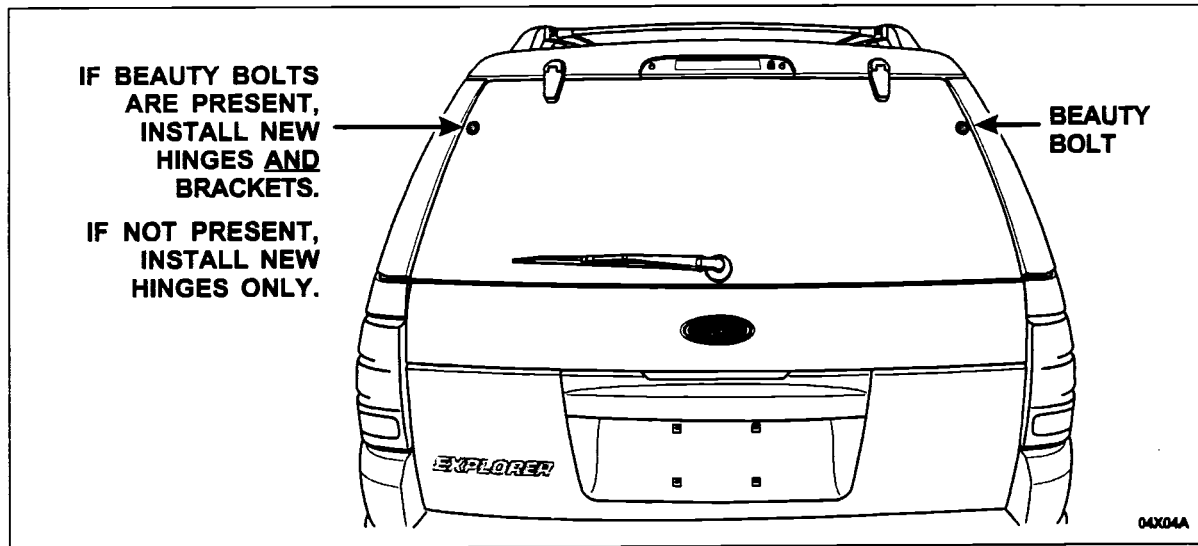
FIGURE 1

To properly identify the vehicle and decide which repairs to perform, inspect for the presence of liftgate glass beauty bolts.

- Early 2002 models use ball stud brackets which are secured with beauty bolts which pass through the glass (the head of the bolt is visible on the outside of the glass) and are bonded to the glass about 150 mm (6 inches) from the top of the glass. See Figure 1. If beauty bolts are present, both the liftgate ball stud brackets and hinges will be replaced. Perform **BOTH** the Liftgate Glass Hinge Replacement and the Ball Stud Bracket Replacement. Begin your repairs with **LIFTGATE GLASS HINGE REPLACEMENT**.
- Later built 2002 and 2003 model year vehicles use revised ball stud brackets which are not secured with beauty bolts. If beauty bolts are not present, only the hinges will be replaced. Perform only the **LIFTGATE GLASS HINGE REPLACEMENT**.
